# JC Termografía RD

**Report for:**  
**Hotel Playa Laguna**  
**Escondido Bay Carretera Cabarete - Sosua, Puerto Plata Republica**  
**Dominicana**  
**Tel : (001) 809 571 3375 956**  
Inspected on: 11/06/2021

## Infra-red Electrical / Pool Inspection Report

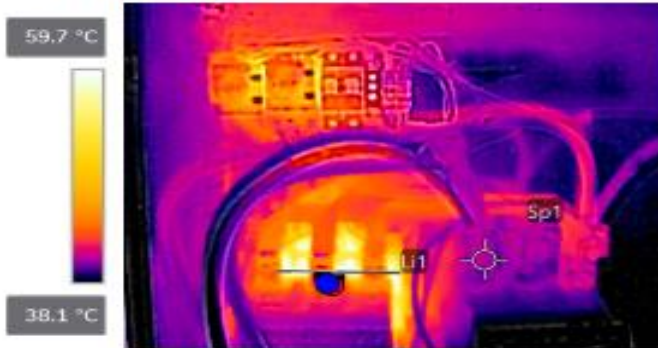
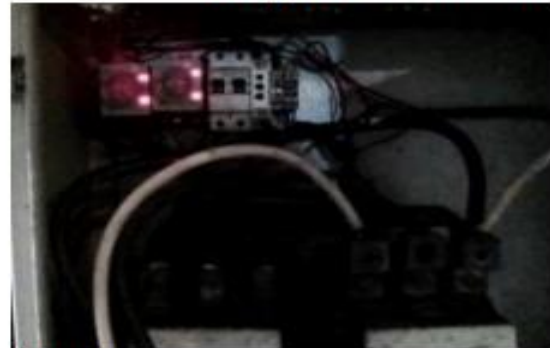
Incoming area main connections

Target Temperature	Reference Temperature	Temperature Difference	Criticality Rating
61.4° C	30° C	31.4° C	**
Amperage A	Amperage B	Amperage C	Rated Amps/Volts
N/A	N/A	N/A	N/A / N/A

Comments: Top lugs are heavily oxidized, maximum temperature is 61.4 degrees Celsius on the center lug of the incoming left contactor.

Recommendations: short term – shutdown power and remove incoming cables one by one, clean copper on cables, clean lugs. Use a burnishing tool (example <https://jonard.com/contact-burnishers-burnisher-files>) or fine sandpaper

Recommendations: long term – change incoming lugs.

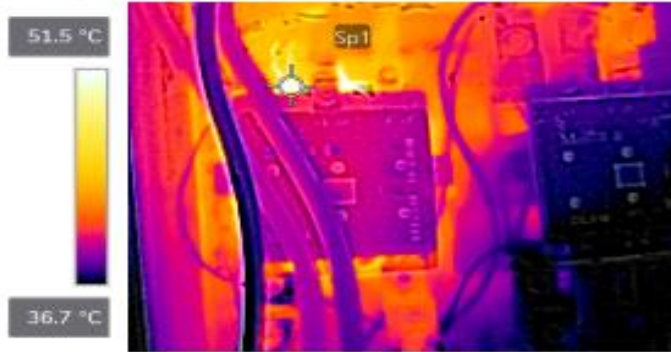
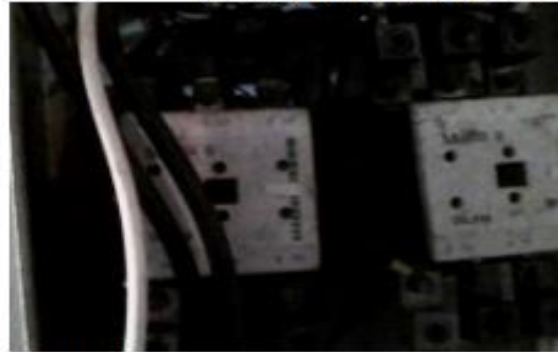
Incoming area main contactors

Target Temperature	Reference Temperature	Temperature Difference	Criticality Rating
53.3° C	30° C	23.3° C	*
Amperage A	Amperage B	Amperage C	Rated Amps/Volts
N/A	N/A	N/A	N/A / N/A

Comments: Contactor lugs are heavily oxidized, maximum temperature of 53.3 degrees Celsius is on left lug of the left contactor.

Recommendations: short term – shutdown power and remove incoming cables one by one, clean copper on cables, clean lugs. Use a burnishing tool as above or fine sandpaper.

Recommendations: long term – due to the age of the contactors and availability of parts, replacement is recommended in the next 5-10 years.

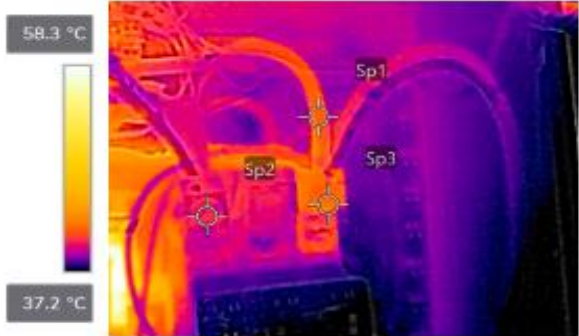
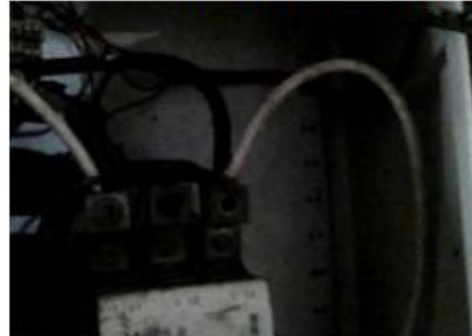
Incoming area right contactor

Target Temperature	Reference Temperature	Temperature Difference	Criticality Rating
42.1° C	30° C	12.1° C	*
Amperage A	Amperage B	Amperage C	Rated Amps/Volts
N/A	N/A	N/A	N/A / N/A

Comments: Contactor lugs are heavily oxidized, maximum temperature of 42.1 degrees Celsius is on the right lug of the right contactor. Note the cables are also warm.

Recommendations: short term – shutdown power and remove incoming cables one by one, clean copper on cables, clean lugs. Use a burnishing tool as above or fine sandpaper.

Recommendations: long term – due to the age of the contactors and availability of parts, replacement is recommended in the next 5-10 years.

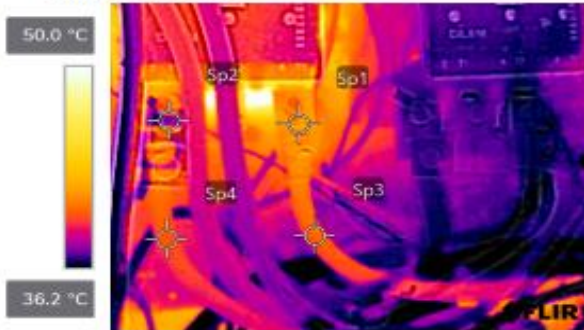
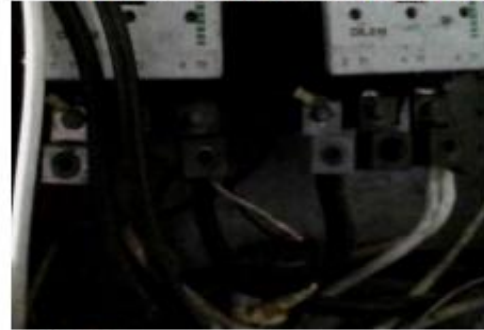
Incoming area left contactor bottom lugs

Target Temperature	Reference Temperature	Temperature Difference	Criticality Rating
41.7° C	30° C	11.7° C	*
Amperage A	Amperage B	Amperage C	Rated Amps/Volts
N/A	N/A	N/A	N/A / N/A

Comments: Contactor lugs are heavily oxidized, maximum temperature of 41.7 degrees Celsius is on the right lug of the left contactor.

Recommendations: short term – shutdown power and remove incoming cables one by one, clean copper on cables, clean lugs. Use a burnishing tool as above or fine sandpaper. Also to note cables are warm.  
 Recommendations: long term – due to the age of the contactors and availability of parts, replacement is recommended in the next 5-10 years.

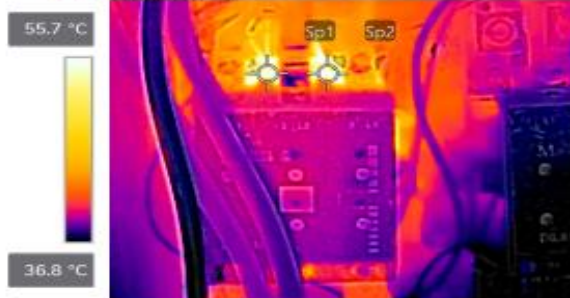
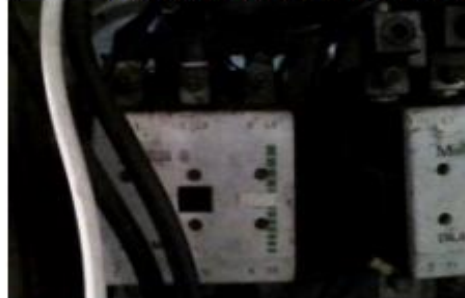
Incoming area top of left contactor

Target Temperature	Reference Temperature	Temperature Difference	Criticality Rating
60.5° C	30° C	30.5° C	**
Amperage A	Amperage B	Amperage C	Rated Amps/Volts
N/A	N/A	N/A	N/A / N/A

Comments: Contactor lugs are heavily oxidized, maximum temperature of 60.5 degrees Celsius is on the center lug of the left contactor.

Recommendations: short term – shutdown power and remove incoming cables one by one, clean copper on cables, clean lugs. Use a burnishing tool as above or fine sandpaper. Also to note cables are warm.  
 Recommendations: long term – due to the age of the contactors and availability of parts, replacement is recommended in the next 5-10 years.

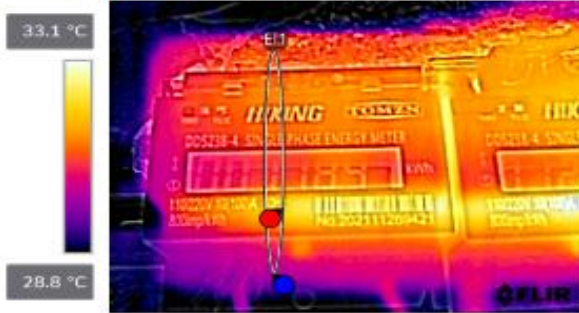
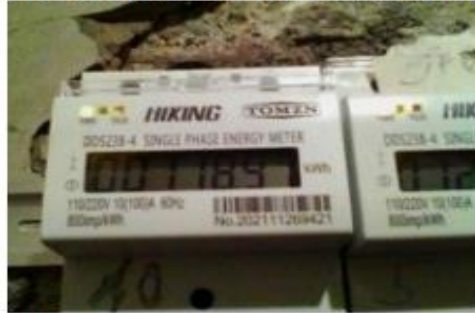
Panel #1 single phase metering section left side

Target Temperature	Reference Temperature	Temperature Difference	Criticality Rating
32.3° C	30° C	2.3° C	
Amperage A	Amperage B	Amperage C	Rated Amps/Volts
N/A	N/A	N/A	N/A / N/A

Comments: No problems detected, temperature normal

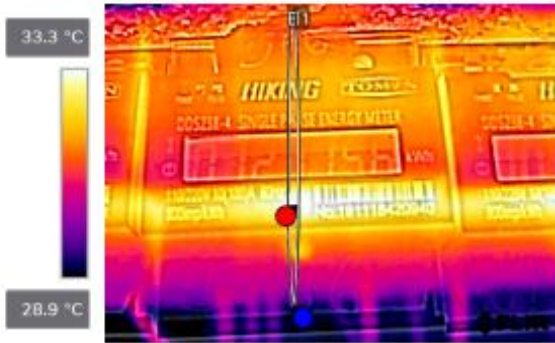
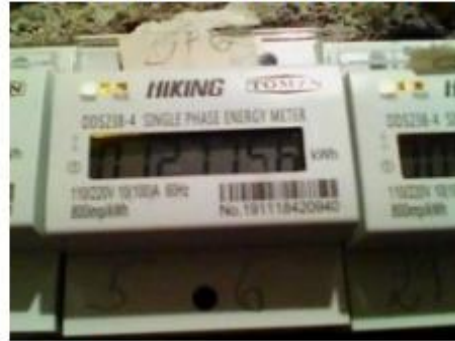
Panel #1 single phase metering section middle

Target Temperature	Reference Temperature	Temperature Difference	Criticality Rating
33.4° C	30° C	3.4° C	
Amperage A	Amperage B	Amperage C	Rated Amps/Volts
N/A	N/A	N/A	N/A / N/A

Comments: No problems detected, temperature normal

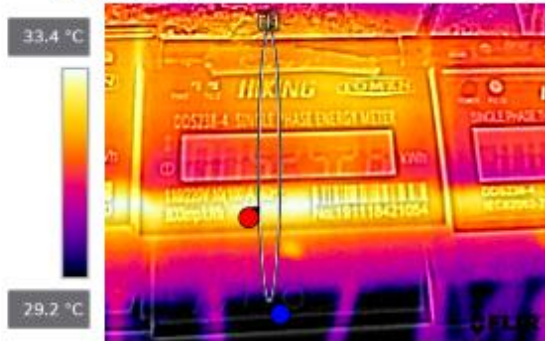
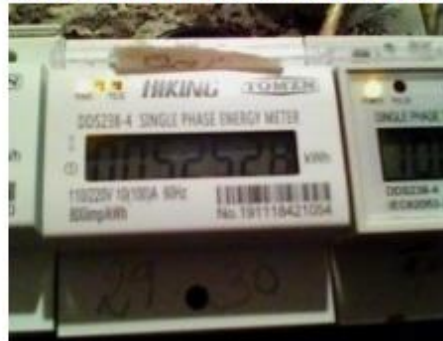
Panel #1 single phase metering section middle right side

Target Temperature	Reference Temperature	Temperature Difference	Criticality Rating
33.3° C	30° C	3.3° C	
Amperage A	Amperage B	Amperage C	Rated Amps/Volts
N/A	N/A	N/A	N/A / N/A
Comments: No problems detected, temperature normal			
Recommendations: short term – none.			
Recommendations: long term – none.

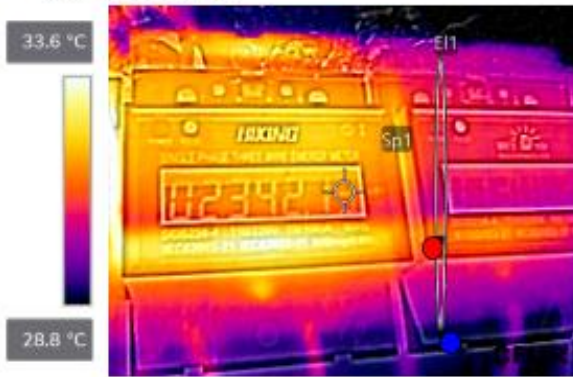
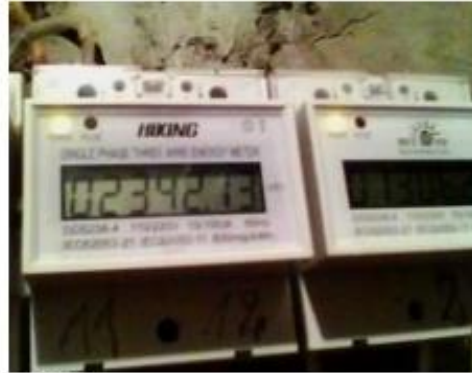
Panel #1 single phase metering section right side

Target Temperature	Reference Temperature	Temperature Difference	Criticality Rating
31.8° C	30° C	1.8° C	
<b>Amperage A</b>	<b>Amperage B</b>	<b>Amperage C</b>	<b>Rated Amps/Volts</b>
N/A	N/A	N/A	N/A / N/A

Comments: No problems detected, temperature normal

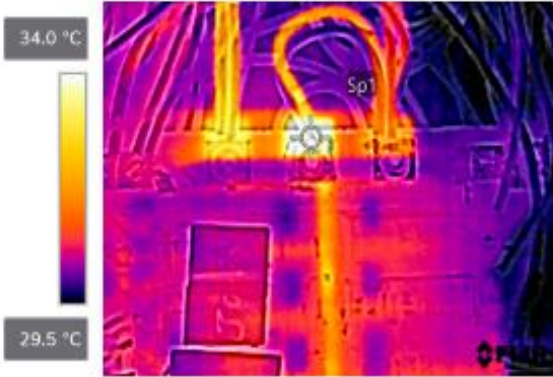
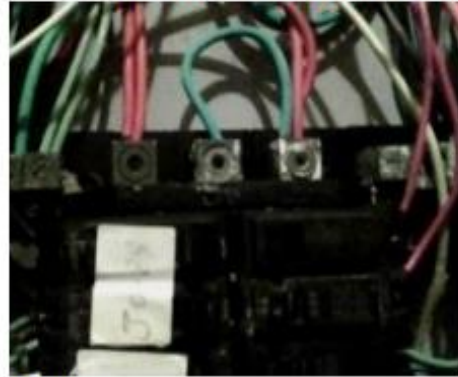
Panel #1 main incoming connections

Target Temperature	Reference Temperature	Temperature Difference	Criticality Rating
34.1° C	30° C	4.1° C	
Amperage A	Amperage B	Amperage C	Rated Amps/Volts
N/A	N/A	N/A	N/A / N/A

Comments: Heavy oxidation on incoming lugs, temperature normal, center lug hotter than others  
 Recommendations: short term – shutdown power and remove incoming cables one by one, clean copper on cables, clean lugs. Use a burnishing tool as above or fine sandpaper. Also to note cables are warm.  
 Recommendations: long term – due to the age of the breaker panel and availability of breakers, replacement is recommended in the next 5-10 years. Also see below some breakers are warm due to oxidation or poor connection to panel main bus bars.

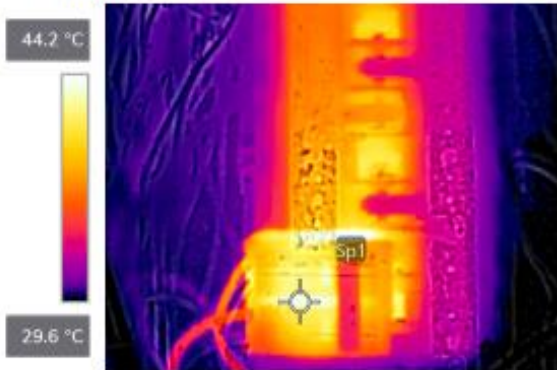
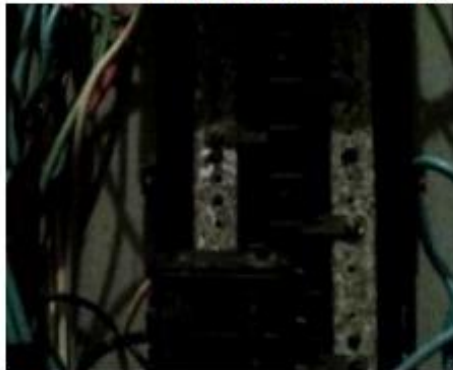
Panel #1 bottom breaker section

Target Temperature	Reference Temperature	Temperature Difference	Criticality Rating
44.0° C	30° C	14.0° C	*
Amperage A	Amperage B	Amperage C	Rated Amps/Volts
N/A	N/A	N/A	N/A / N/A

Comments: Heavy oxidation on panel bus bars, temperature warm, bottom breakers hotter than others  
 Recommendations: short term – Remove and reinstall breakers ensure they fit snugly. Also to note cables are warm.  
 Recommendations: long term – due to the age of the breaker panel and availability of breakers, replacement is recommended in the next 5-10 years.

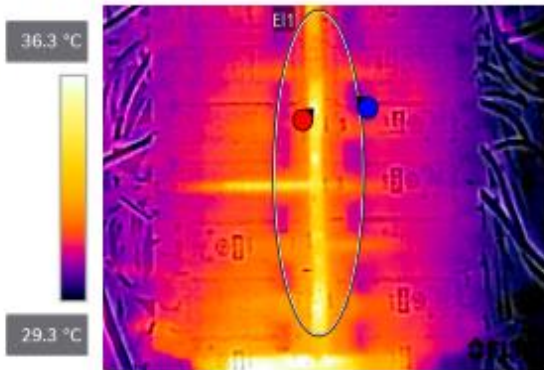
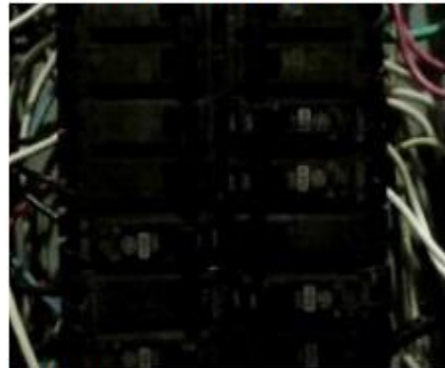
Panel #1 breakers in the middle section

Target Temperature	Reference Temperature		Temperature Difference	Criticality Rating
36.8° C	30° C		6.8° C	
Amperage A	Amperage B		Amperage C	Rated Amps/Volts
N/A	N/A		N/A	N/A / N/A
Comments: Heavy oxidation on panel bus bars, temperature warm.				
Recommendations: short term – Remove and reinstall breakers ensure they fit snugly. Recommendations: long term – due to the age of the breaker panel and availability of breakers, replacement is recommended in the next 5-10 years.

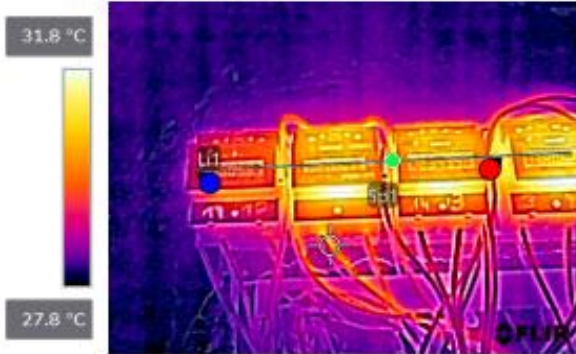
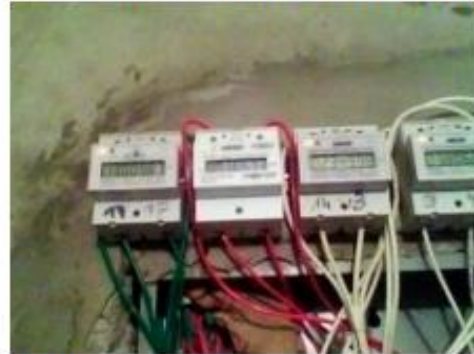
Panel #2 metering section left to middle

Target Temperature	Reference Temperature	Temperature Difference	Criticality Rating
31.4° C	30° C	1.4° C	
Amperage A	Amperage B	Amperage C	Rated Amps/Volts
N/A	N/A	N/A	N/A / N/A
Comments: No problems detected, temperature normal			
Recommendations: short term – none.			
Recommendations: long term – none.

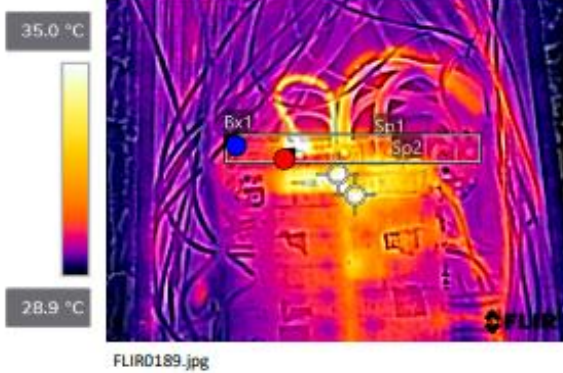
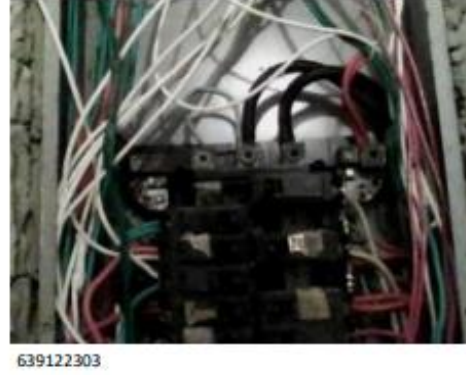
Panel #2 incoming connections and top breakers

Comments: Heavy oxidation on incoming lugs, temperature normal, left lug hotter than others  
 Recommendations: short term – shutdown power and remove incoming cables one by one, clean copper on cables, clean lugs. Use a burnishing tool as above or fine sandpaper. Also to note cables are warm.  
 Recommendations: long term – due to the age of the breaker panel and availability of breakers, replacement is recommended in the next 5-10 years. Also see below some breakers are warm due to oxidation or poor connection to panel main bus bars.

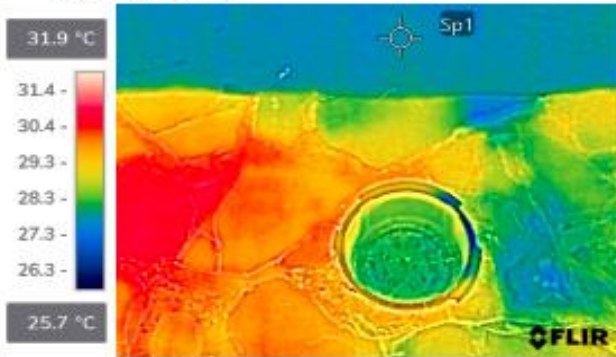
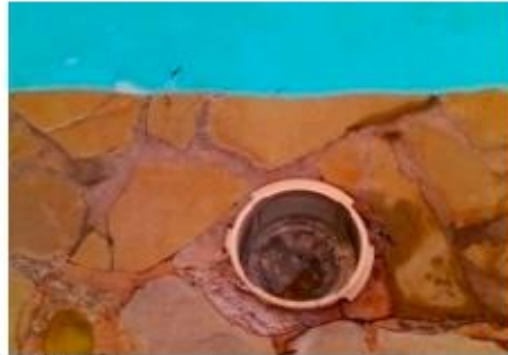
Pool inlet strainer area

Comments: Pool temperature is 27.7 degrees Celsius, deck temperature is 30.7 degrees Celsius. No leak detected.

Recommendations: None, scan was done for information only, typical leaks are around strainers and outlet piping.

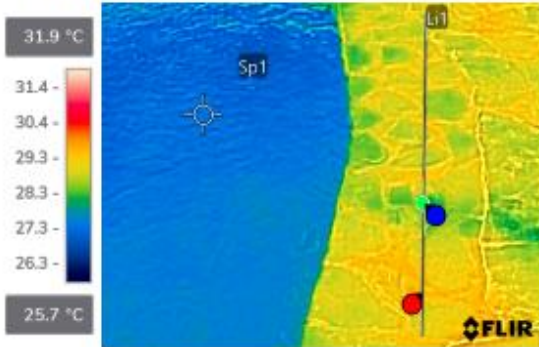
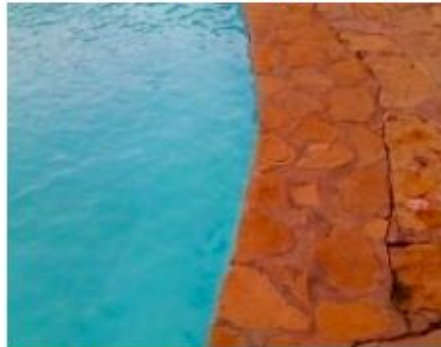
Pool left edge middle section

Comments: Pool temperature is 27.7 degrees Celsius, deck temperature is average 29.0 degrees Celsius as detected by line. No leak detected.

Recommendations: None, scan was done for information only, typical leaks are around strainers and outlet piping.

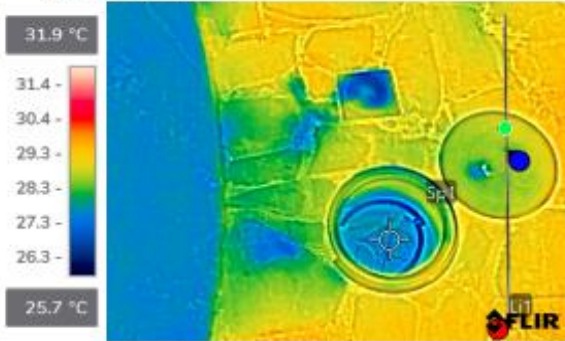
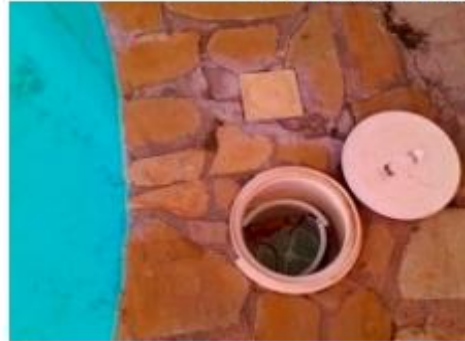
Pool 2nd inlet strainer

Comments: Pool temperature measured in strainer is 27.6 degrees Celsius, deck temperature is average 29.0 degrees Celsius as detected by line. No leak detected.

Recommendations: None, scan was done for information only, typical leaks are around strainers and outlet piping.
