Report for:
Mike's Mountain Saloon
Mountain Top near Moca
Tel : (+49) 173 537 6669
Inspected on: 11/27/2021

Infra-red Electrical Inspection Report

Location / Name: Mike's Mountain Saloon, Main Building

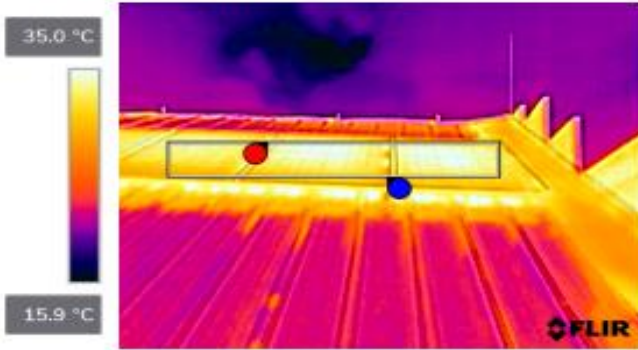
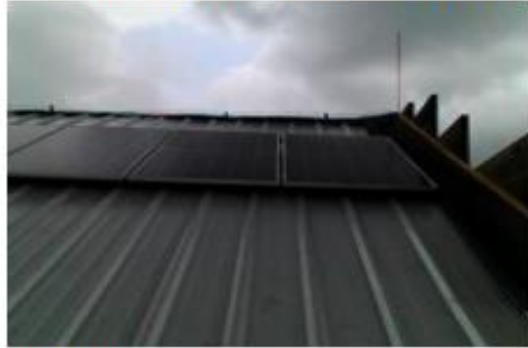
Roof solar panels 3 sections on the right

Comments: 7.6° C difference is due to placement of the sun, no hot spots or other anomalies detected.
 Recommendations: short term –None
 Recommendations: long term – Add more solar panels as facility grows and requires.

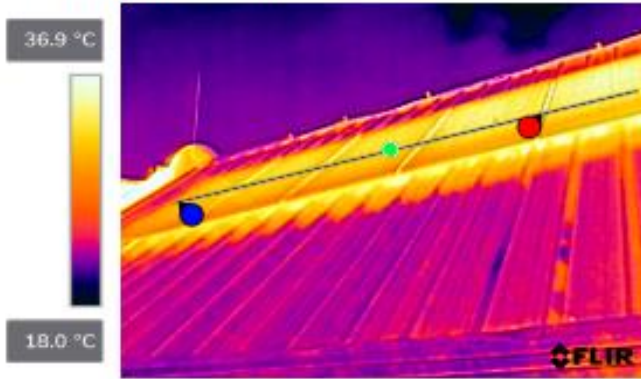
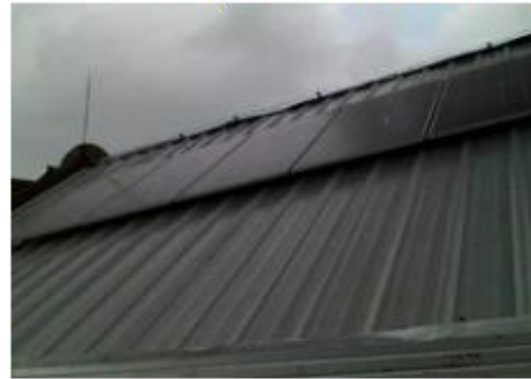
Roof solar panels 4 sections on the left

Comments: 5.0° C difference is due to placement of the sun, no hot spots or other anomalies detected.

Recommendations: short term –None

Recommendations: long term – Add more solar panels as facility grows and requires.

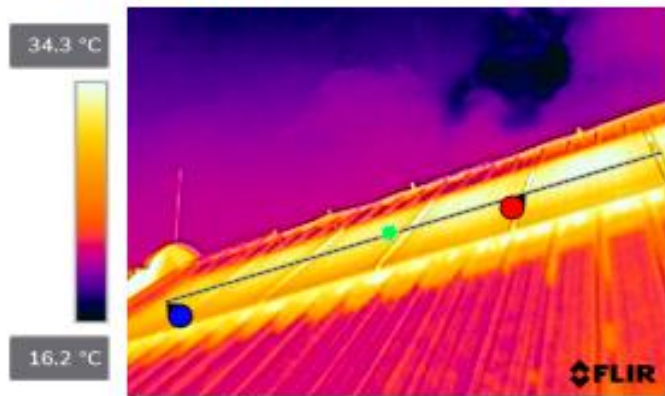
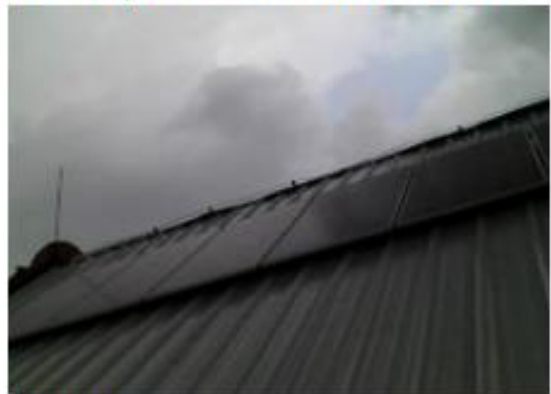
Roof solar panels 4 sections on the left 2nd shot

Comments: 5.3° C difference is due to placement of the sun, no hot spots or other anomalies detected.

Recommendations: short term –None

Recommendations: long term – Add more solar panels as facility grows and requires.

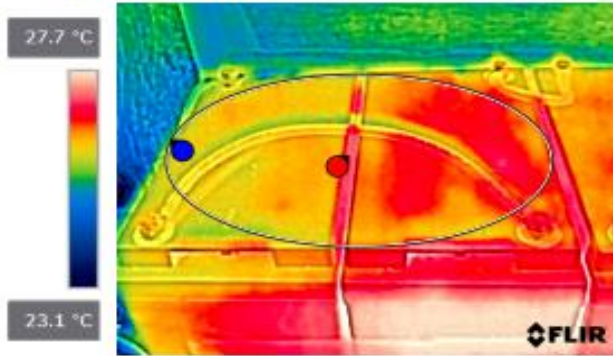
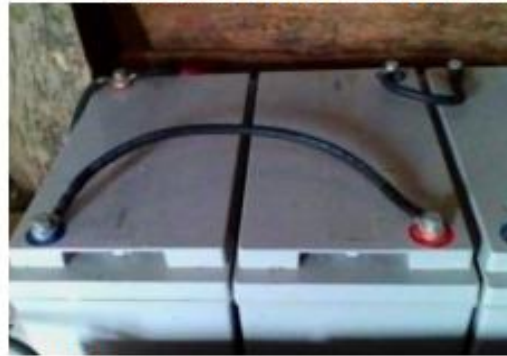
Solar storage batteries 1st row #1 & #2

Comments: -1.8° C difference is due to placement of the Electrical/Pump room under the Saloon, no hot spots or other anomalies detected. All connections tight, cables no signs of heat. String V – 48V – 51.8V

Recommendations: short term –None

Recommendations: long term – Add more batteries as facility grows and requires.

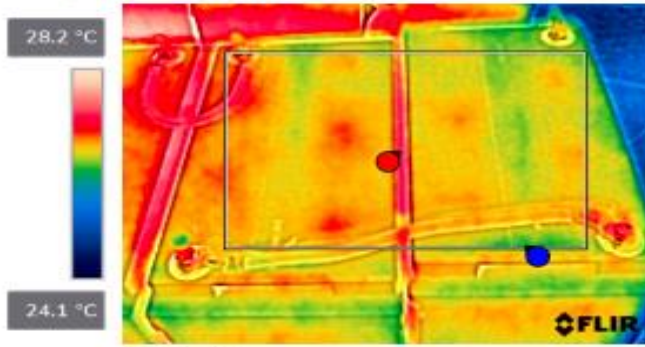
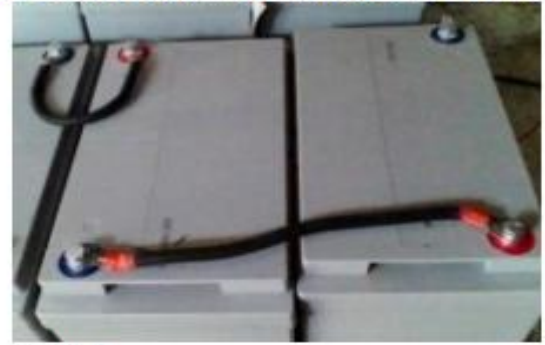
Solar storage batteries 2nd row batteries #3 and #4

Comments: -1.8° C difference is due to placement of the Electrical/Pump room under the Saloon, no hot spots or other anomalies detected. All connections tight, cables no signs of heat. String V – 48V – 51.8V

Recommendations: short term –None

Recommendations: long term – Add more batteries as facility grows and requires.

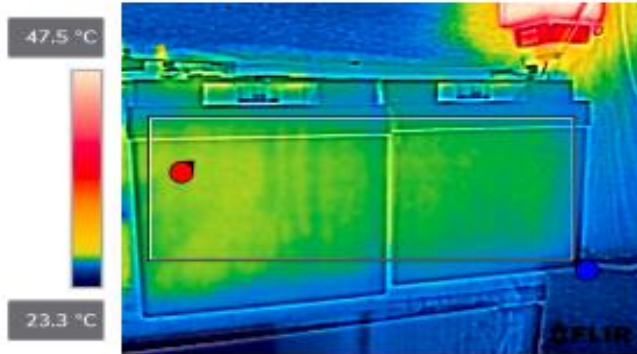
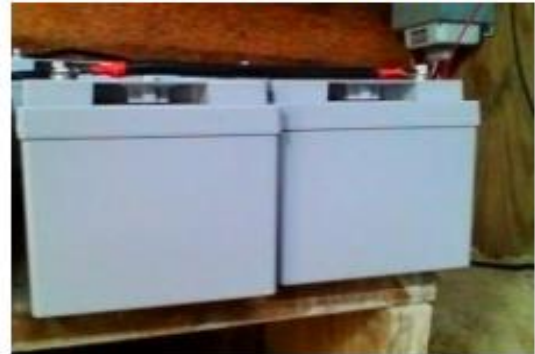
Solar storage batteries 2nd row batteries #3 and #4 front face

Comments: -1.9° C difference is due to placement of the Electrical/Pump room under the Saloon, no hot spots or other anomalies detected. All connections tight, cables no signs of heat. String V – 48V – 51.8V

Recommendations: short term –None

Recommendations: long term – Add more batteries as facility grows and requires.

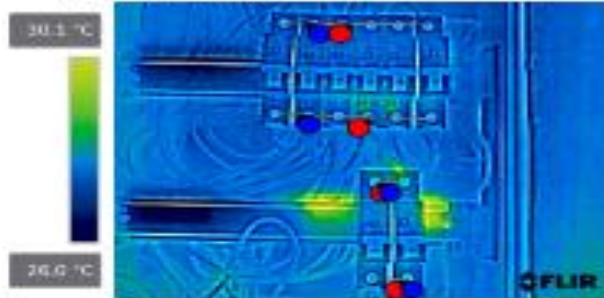
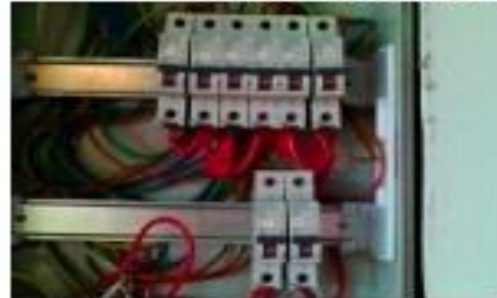
Breaker panel in saloon area

Comments: -1.0 difference is due to breeze at the Electrical panel. No hot spots or other anomalies detected. All connections tight, cables no signs of heat. All voltages balanced 114V

Recommendations: short term –None

Recommendations: long term – None panel almost at capacity.

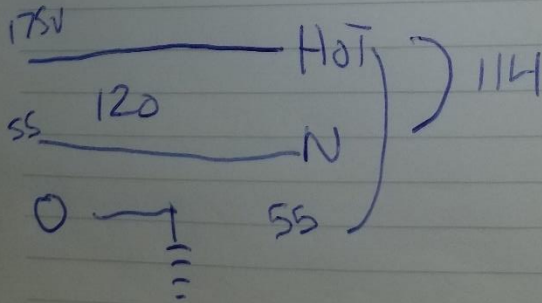
We discovered a 27 - 55V difference between the ground bar and the neutral bar in the breaker distribution panel behind the bar of the saloon. We also spent a couple of hours tracing the distribution from the breaker panel and noting which breakers power which lights and plugs. In our investigation it was noted that there are 2 outputs from the 6000W inverter, 1 - 3000w output goes to the panel behind the bar, the second goes directly to the water pump. The reason this is important to know is the breaker panel at the bar seems fairly full whereas the 2nd leg at the water pump has plenty of capacity. As well as performing a full thermal scan, voltages and currents were measured and are listed below in a table for your reference. A series of handwritten notes are included at the bottom also for reference.

* IN DISTRIBUTION PANEL

IN SALOON

230V From BLUE NEUTRAL

↓ To GND

55V

Facility recommendation: Have original electrician that has completed all work to date check grounding and bonding of inverter and all electrical equipment. This should resolve the 27 - 55VAC differential between neutral and ground. Note in a properly grounded system the Neutral should equal the ground and measured from hot – neutral = 120V and hot to ground 120V and Neutral – ground 0V. within 5%
