JC Termografía RD

Super 8 Motel 1956 Regent St, Sudbury ON P3E 3Z9

Inspected on: 11/06/2021

Infra-red Electrical Report

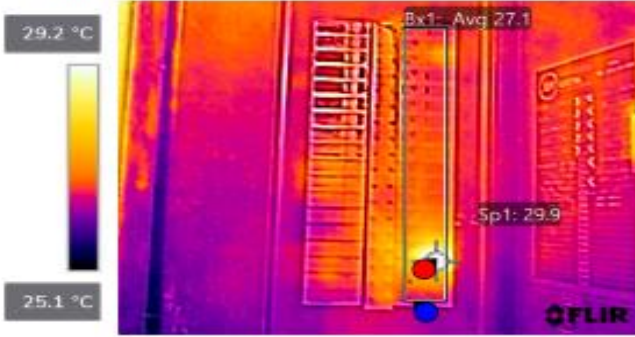
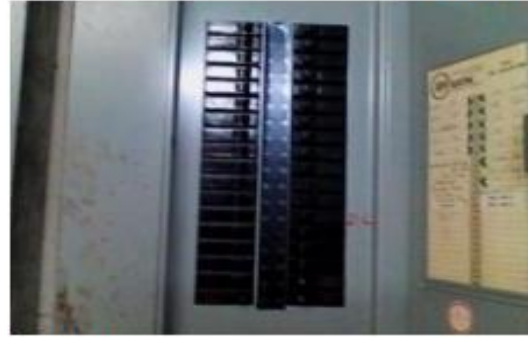
Panel G-1

Target Temperature	Reference Temperature	Temperature Difference	Criticality Rating
29.9° C	20° C	9.9° C	
Amperage A	Amperage B	Amperage C	Rated Amps/Volts
N/A	N/A	N/A	N/A / N/A

Comments: 2 breakers appear hotter than others.

Recommendations: Recommendations: Inspect again with thermal camera with cover removed and take amperage and voltage readings.

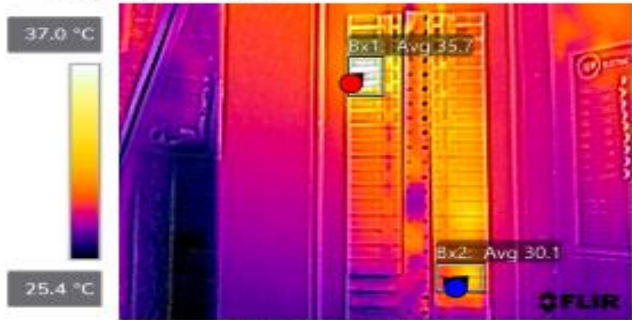
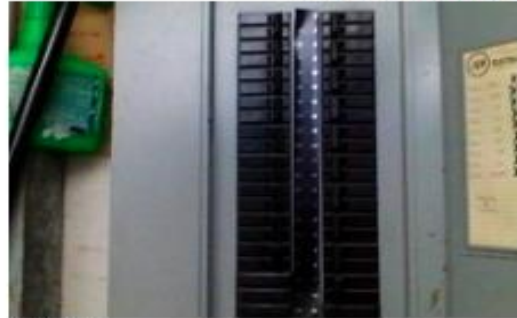
Panel to the left of G-1

Target Temperature	Reference Temperature	Temperature Difference	Criticality Rating
39.8° C	20° C	19.8° C	*
Amperage A	Amperage B	Amperage C	Rated Amps/Volts
N/A	N/A	N/A	N/A / N/A

Comments: 5 breakers appear hotter than others.

Recommendations: Inspect again with thermal camera with cover removed and take amperage and voltage readings.

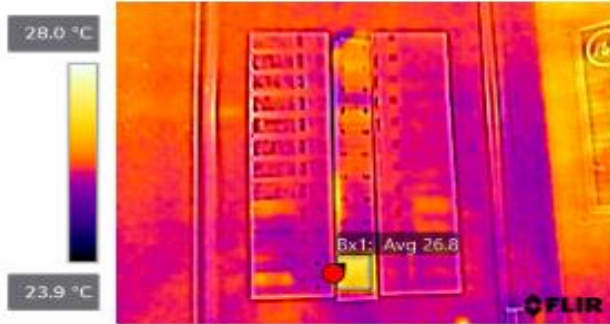
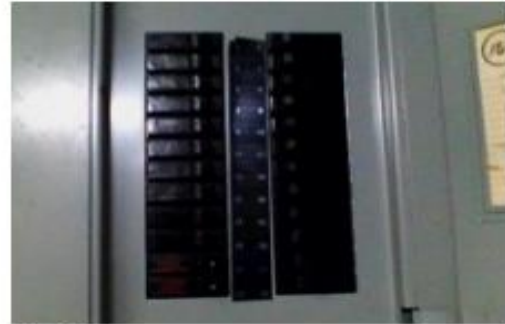
Panel to the right of G-1

Target Temperature	Reference Temperature	Temperature Difference	Criticality Rating
27.1° C	20° C	7.1° C	
Amperage A	Amperage B	Amperage C	Rated Amps/Volts
N/A	N/A	N/A	N/A / N/A

Comments: 3 breakers appear hotter than others.

Recommendations: Inspect again with thermal camera with cover removed and take amperage and voltage readings.

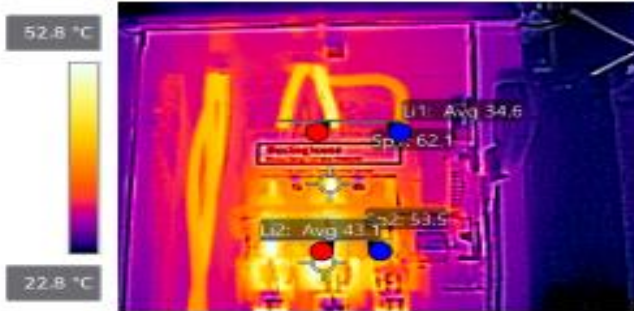
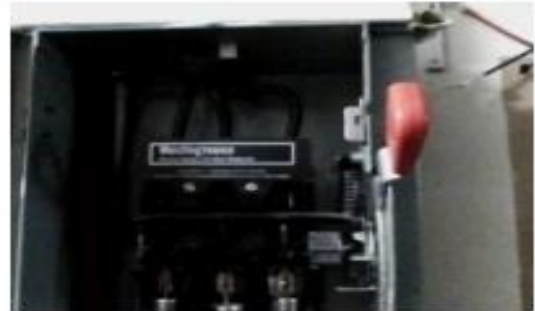
Dryer 2 disconnect top section

We discovered some high temperature connections in the dryer 2 disconnect. There is further action recommended on the dryer 2 disconnect.

Target Temperature	Reference Temperature	Temperature Difference	Criticality Rating
62.1° C	20° C	42.1° C	***
Amperage A	Amperage B	Amperage C	Rated Amps/Volts
N/A	N/A	N/A	N/A / N/A
Comments: seeing some localized hot spots on the fuses, seeing differential temperatures across all 3 phases			
Recommendations: the difference across all three phases may be normal. Shut down at motel's convenience, remove all 3 fuses clean with a burnishing stick or fine sandpaper. Also clean fuse finger holders, reinstall fuses. In the future a second more detailed scan could be preformed to ensure connections are cooler, next time inspection should include voltage and amperage readings

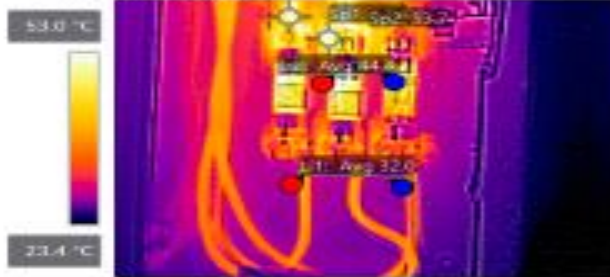
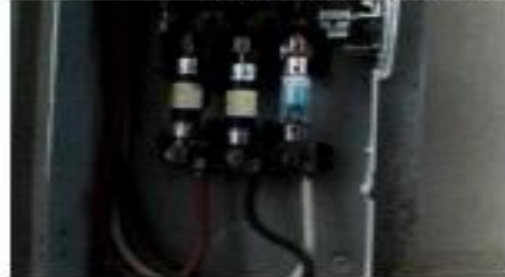
Dryer 2 disconnect fuse area

Target Temperature	Reference Temperature	Temperature Difference	Criticality Rating
57.4° C	20° C	37.4° C	**
Amperage A	Amperage B	Amperage C	Rated Amps/Volts
N/A	N/A	N/A	N/A / N/A

Comments: seeing some localized hot spots on the fuses, seeing differential temperatures across all 3 phases.

Recommendations: the difference across all three phases may be normal. Shut down at motel's convenience, remove all 3 fuses clean with a burnishing stick or fine sandpaper. Also clean fuse finger holders, reinstall fuses. In the future a second more detailed scan could be preformed to ensure connections are cooler, next time inspection should include voltage and amperage readings

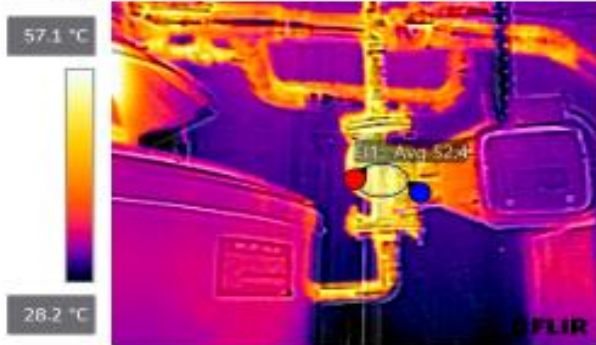
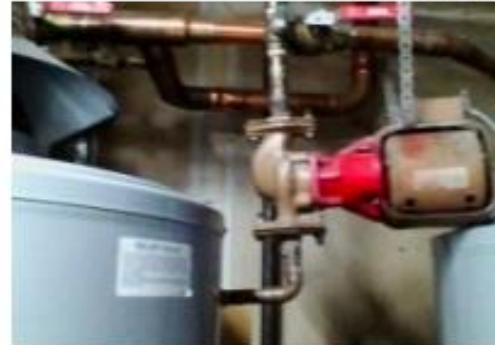
Hot water pump

Target Temperature	Reference Temperature	Temperature Difference	Criticality Rating
53.4° C	20° C	33.4° C	
Amperage A	Amperage B	Amperage C	Rated Amps/Volts
N/A	N/A	N/A	N/A / N/A

Comments: used the hot water valve as a reference.

Recommendations: short term – none.

Recommendations: long term – none.

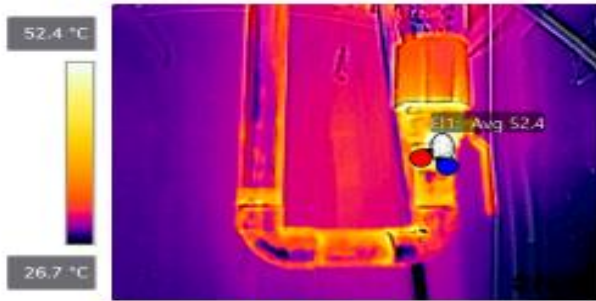
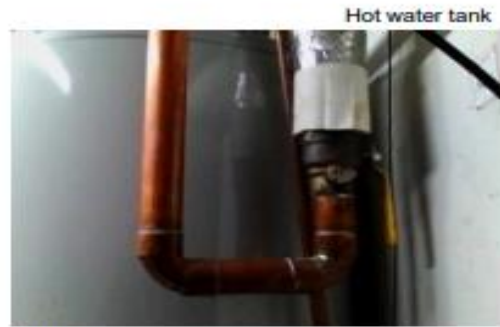
Hot water tank - thermal.jpg

Target Temperature	Reference Temperature	Temperature Difference	Criticality Rating
55.2° C	20° C	25.2° C	
Amperage A	Amperage B	Amperage C	Rated Amps/Volts
N/A	N/A	N/A	N/A / N/A
Comments: No problems detected, temperature normal			
Recommendations: short term – none.			
Recommendations: long term – none.

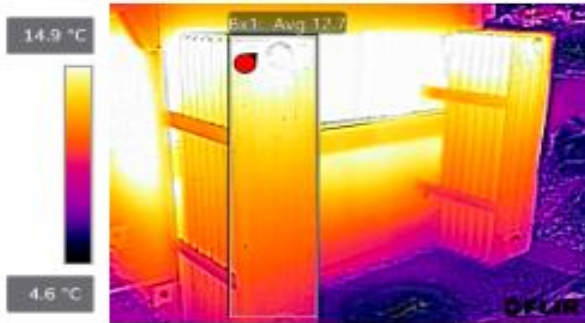
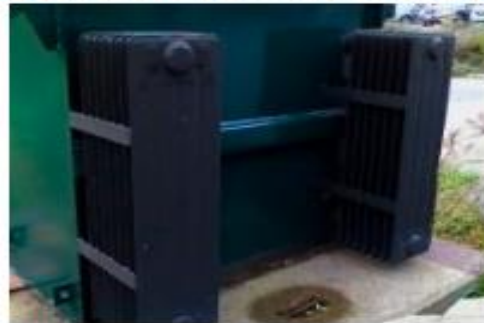
Main transformer Incoming area main connections

Target Temperature	Reference Temperature	Temperature Difference	Criticality Rating
33.4° C	10° C	23.4° C	
Amperage A	Amperage B	Amperage C	Rated Amps/Volts
N/A	N/A	N/A	N/A / N/A

Comments: scanned the outdoor transformer to verify that the cooling fins were not blocked. Transformer working fine, no temperature issues.

Recommendations: short term – none.

Recommendations: long term – none.
