JC Termografía RD

Calle Villa Karibik URB. LA MULATA

Inspected on: 01/18/2024

Infra-red / Electrical Report

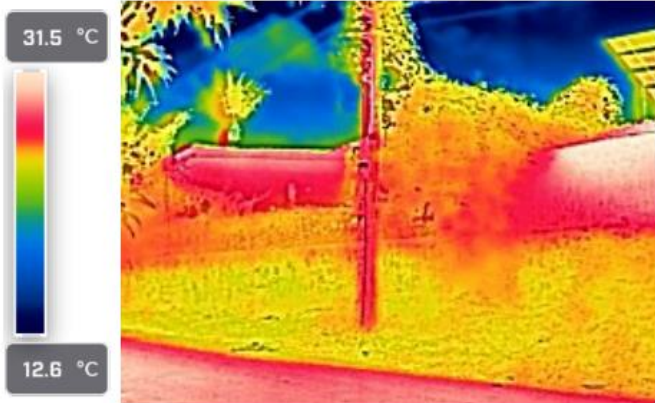
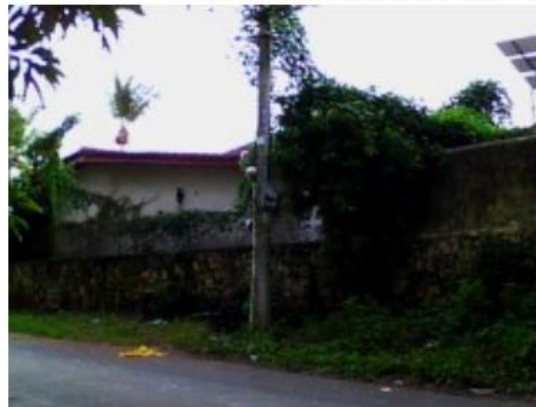
FLIR0831.jpg

Incoming power from this pole?

Comments: Pole transformer across the street – picture for reference only no thermal analysis.

Recommendations: None for reference only

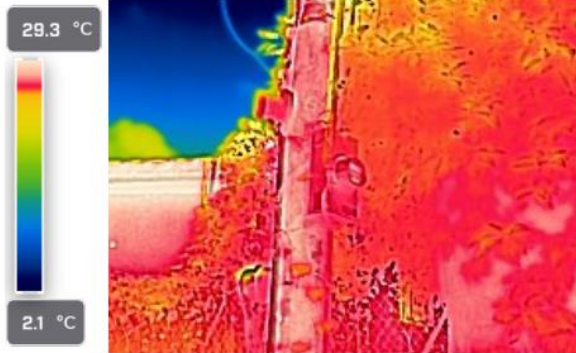
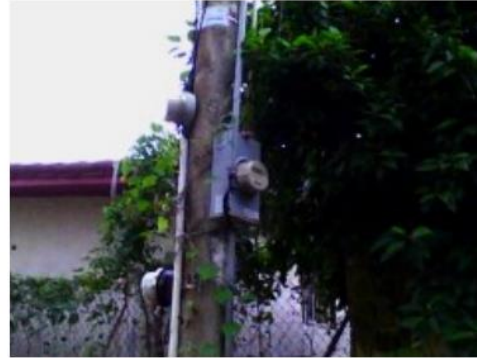
FLIR0833.jpg

Incoming power pole?

Target Temperature	Reference Temperature	Temperature Difference	Criticality Rating
N/A	N/A	N/A	
Amperage A	Amperage B	Amperage C	Rated Amps/Volts
N/A	N/A	N/A	100A / 120/220V
Comments: Pole transformer across the street – picture for reference only no thermal analysis.			
Recommendations: None for reference only

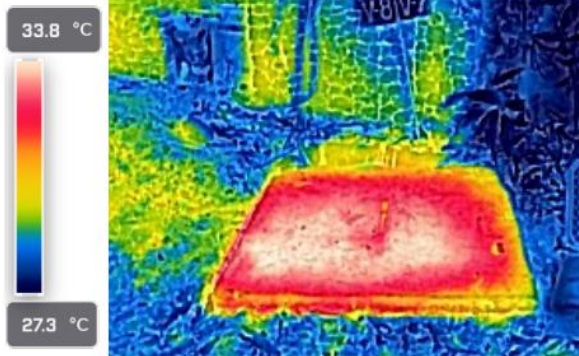
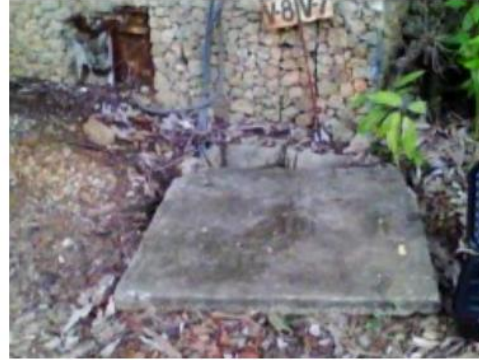
FLIR0829.jpg

Incoming area ground pit

Target Temperature	Reference Temperature	Temperature Difference	Criticality Rating
N/A	N/A	N/A	
Amperage A	Amperage B	Amperage C	Rated Amps/Volts
N/A	N/A	N/A	100A / 120/220V
Comments: Incoming pit area – picture for reference only no thermal analysis.			
Recommendations: None for reference only

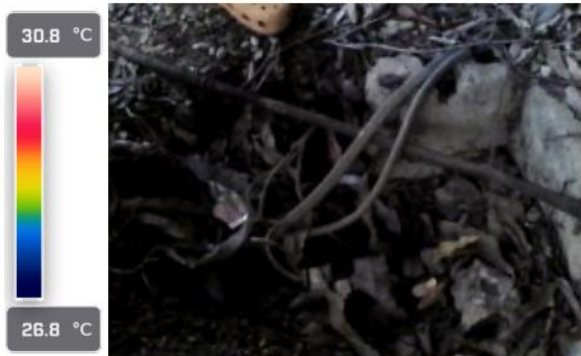
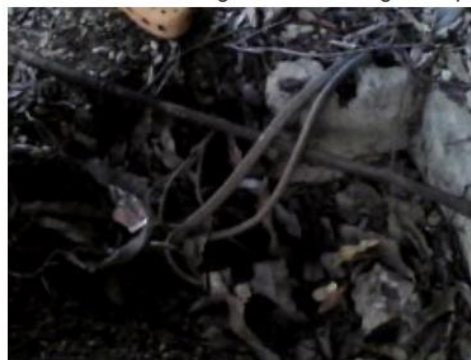
FLIR0837.jpg

Incoming area cables in ground pit

Comments: Incoming pit area showing cables in ground – picture for reference only – no thermal analysis.
 Recommendations - short term: patch up cables with appropriate rated heat shrink repair kit, make proper connections using bolted connections or insulated motor type connections. Ensure all connections are waterproof.(see pictures at bottom of this report)
 Recommendations – long term: re run cables new from pole transformer directly to high side of power meters with no breaks in cables, bury in properly rated conduit or bus duct and fill with firestop or equivalent to keep water from intruding and filling conduits and damaging cables.

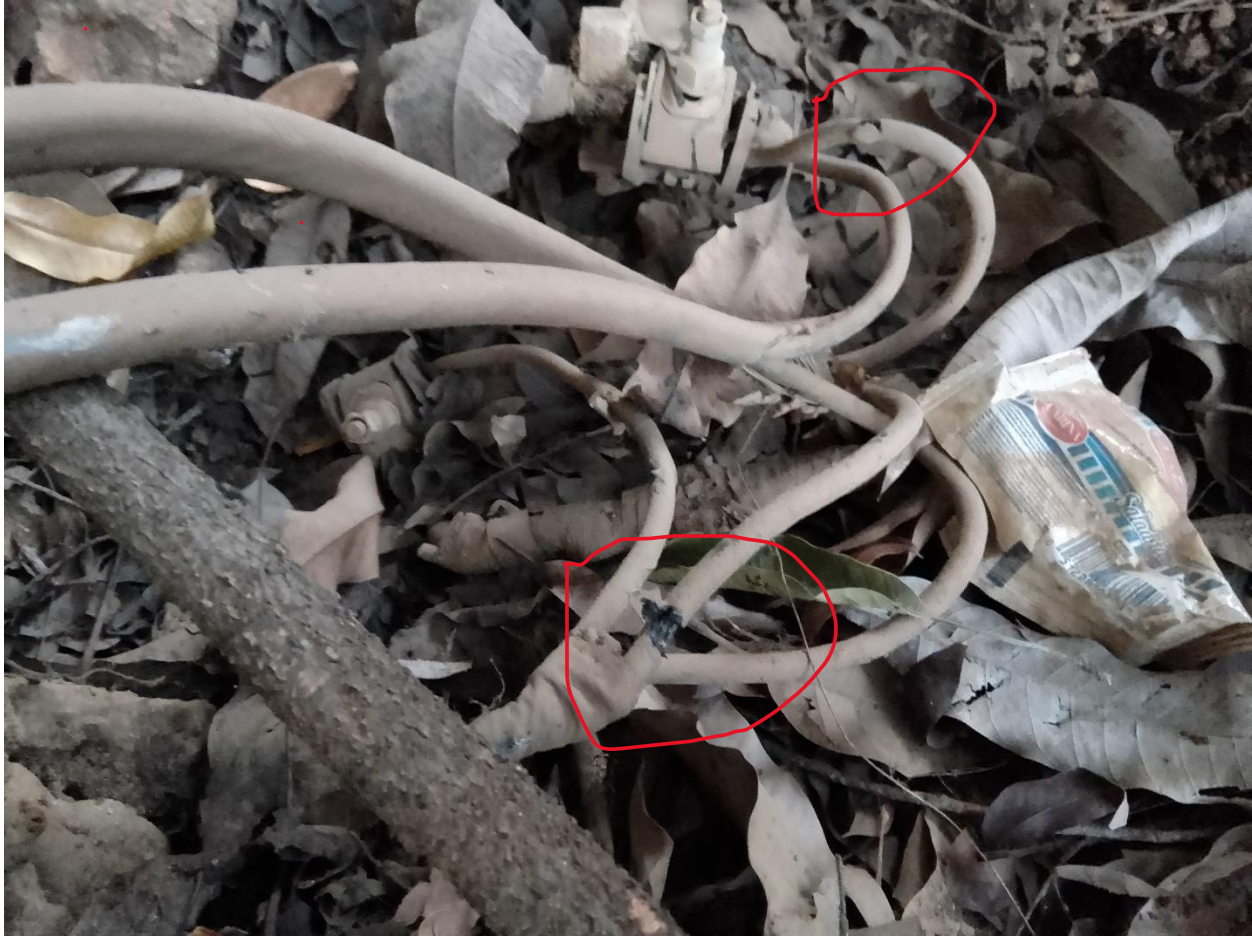
Target Temperature	Reference Temperature	Temperature Difference	Criticality Rating
N/A	N/A	N/A	
Amperage A	Amperage B	Amperage C	Rated Amps/Volts
N/A	N/A	N/A	100A / 120/220V
Comments: Incoming pit area showing damaged cables in ground – picture for reference only			
Recommendations: As above.

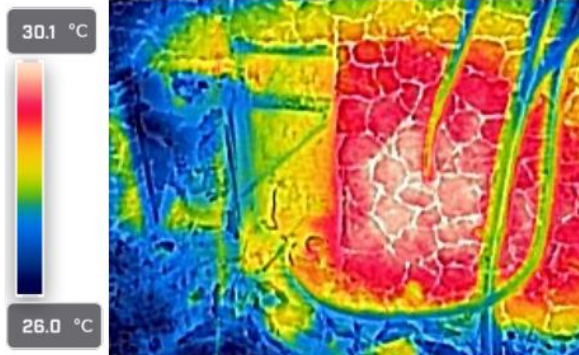
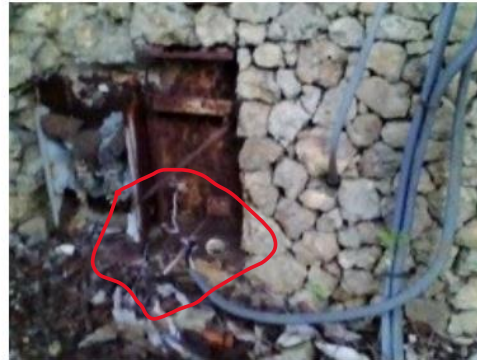
FLIR0825.jpg

Main Incoming connections to meter socket

Comments: Incoming connection to meter socket – picture for reference only, no thermal analysis.

Recommendations – short term: repair junction box and cover, remake proper connections either bolted or motor rated insulated connectors. (see pictures at end of report)

Recommendations – long term: re run new cable directly from pole transformer to power meter bypassing this junction box.

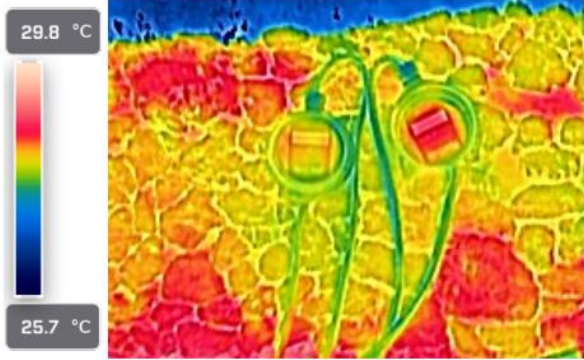
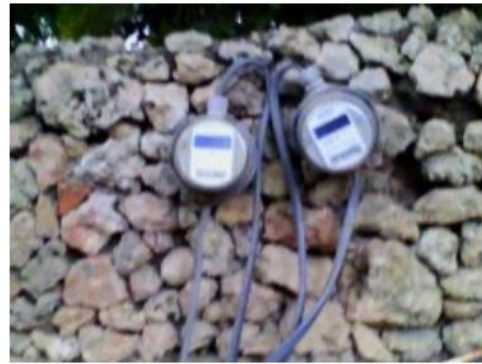
FLIR0827.jpg

Main meter sockets 120V and 220V

Comments: Incoming meter sockets – picture for reference only

Recommendations: As above recommendations, when entering new cables fabricate a bracket to affix both securely and level.

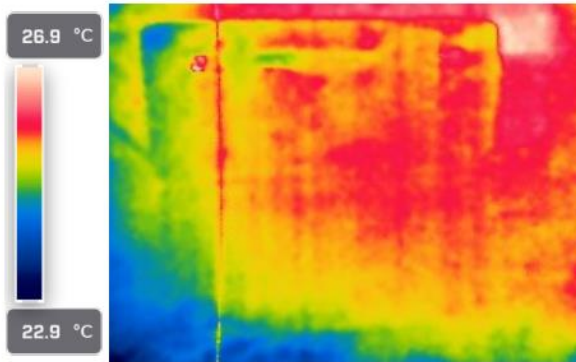
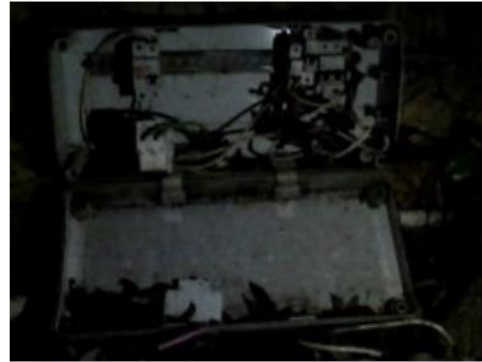
FLIR0839.jpg

Villa incoming power from low side of power meters – we discovered the main junction box is not closed and secured, there are old redundant breakers in the box, there are poorly connected wires on breakers, there are breakers not secured to the panel, there are neutral and ground wires not securely attached, there are wires not rated for direct burial leaving the box and buried prior to entering “conduits”. See pages 13 and 14.

main customerconnection point after meter sockets

Recommendations – short term: 1) close and secure junction box, ensure seal to keep water out. 2) remove unused, damaged breakers to free up space and make troubleshooting less confusing. 3) remove and reconnect cables to breakers ensuring proper connections. Remove temporary joints in neutrals and grounds and use proper bolted connections. 4) secure all breakers to backplate of panel, ensure DIN rail is grounded. 5) Dig up bare buried wires and cover in heat shrink or another suitable mechanical protection and plug up conduit entries with firestop or similar to keep water out.

Recommendations – long term: replace box and all breakers, redo all connections, extend conduits to the junction box and ensure conduits are properly sealed. Also ensure all wires are properly rated for the amperage required.

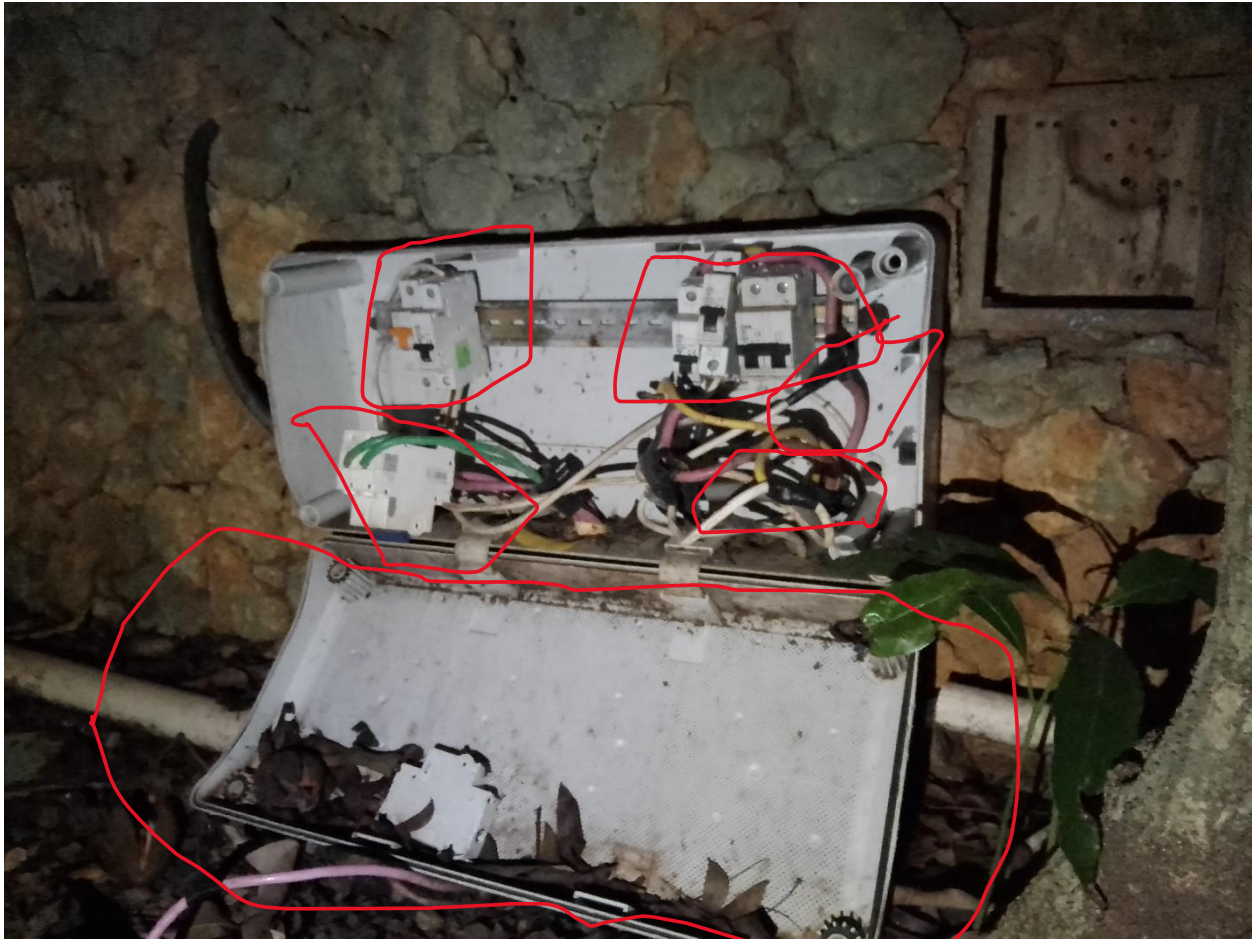
Target Temperature	Reference Temperature	Temperature Difference	Criticality Rating
N/A	N/A	N/A	
Amperage A	Amperage B	Amperage C	Rated Amps/Volts
N/A	N/A	N/A	100/A / 120/220V
Comments: Incoming power connections from meter sockets – picture for reference only, no thermal analysis.			
Recommendations: As above.

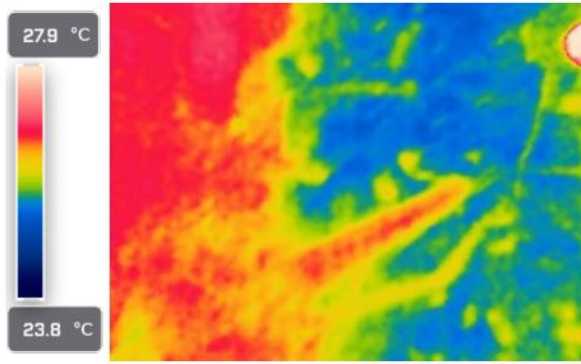
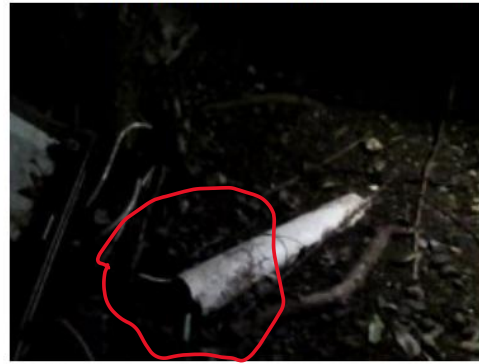
FLIR0841.jpg

Villa power distribution from main junction box to villa cellar – we discovered that there are many instances of “conduits” not being connected, not being sealed against water and I use the term “conduits” because these are not proper electrical conduits, these are plastic pipe that is not rated for containing cables in a direct burial situation. Also cables are improperly buried in the earth without mechanical protection as they run to the “conduits”, none of the “conduits” are sealed against water intrusion. See pages 15 to 18.

Conduit from main connection box to villa

Recommendations: Short term: seal conduit with appropriate sealant and mechanically protect exposed cable.

Recommendations: Long term: replace conduit with appropriate type, ensure conduit runs end to end with no breaks and fill ends with appropriate conduit sealer once re-installed.

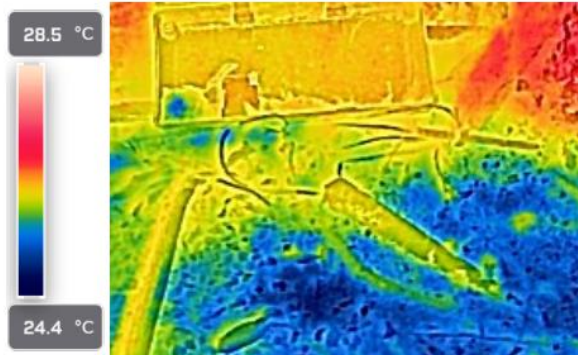
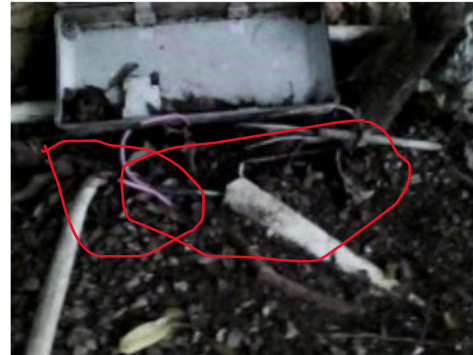
FLIR0861.jpg

Conduits from main connection point to villa

Recommendations: Short term: seal conduit with appropriate sealant and mechanically protect exposed cable.

Recommendations: Long term: replace conduit with appropriate type, ensure conduit runs end to end with no breaks and fill ends with appropriate conduit sealer once re-installed.

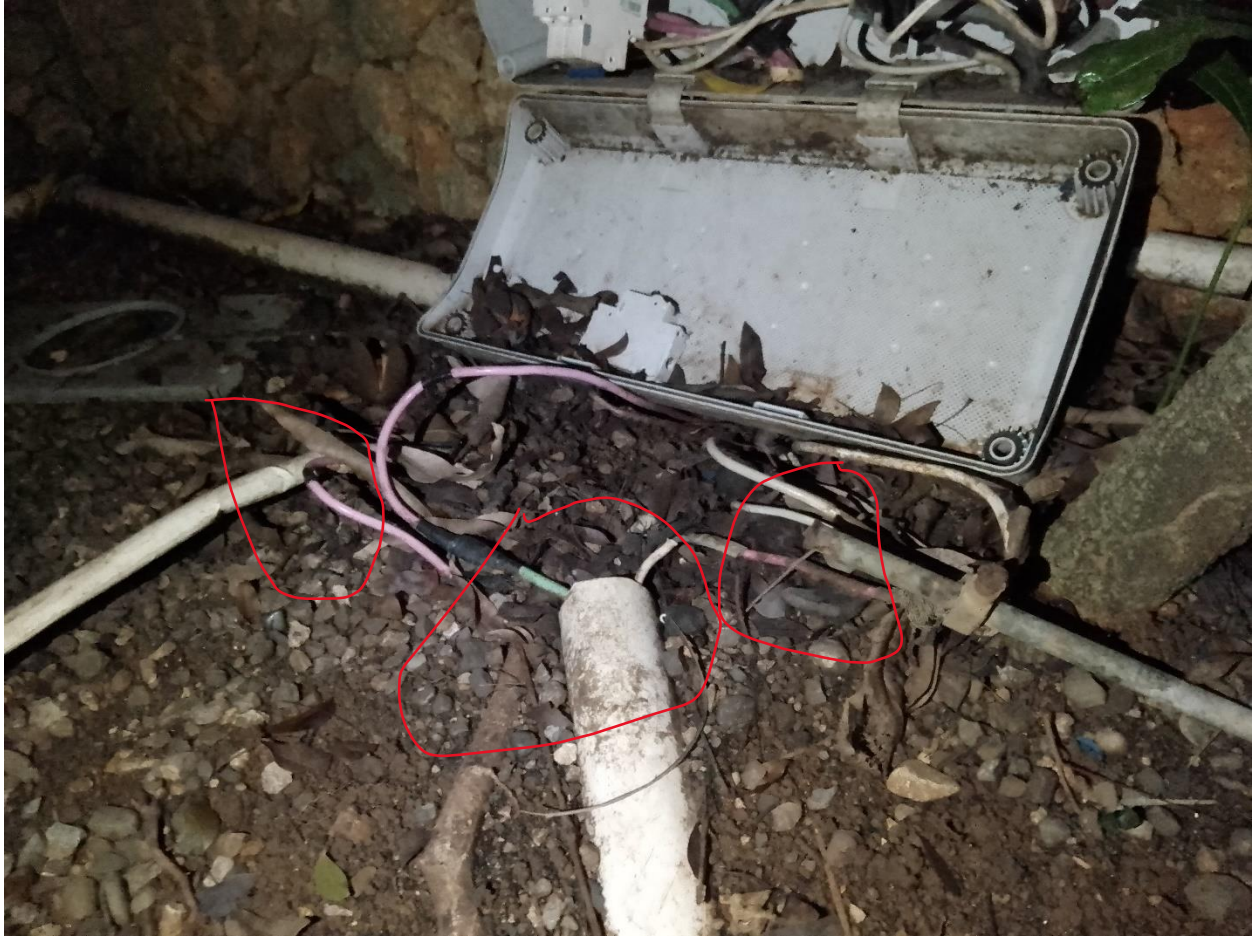
Target Temperature	Reference Temperature	Temperature Difference	Criticality Rating
N/A	N/A	N/A	
Amperage A	Amperage B	Amperage C	Rated Amps/Volts
N/A	N/A	N/A	100A / 120/220V
Comments: Distribution conduit from Incoming power connections to villa – picture for reference only			
Recommendations: As above.

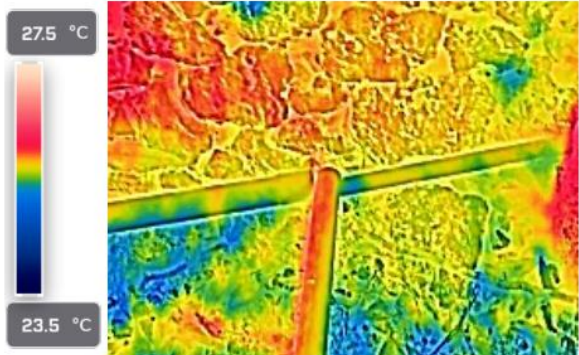
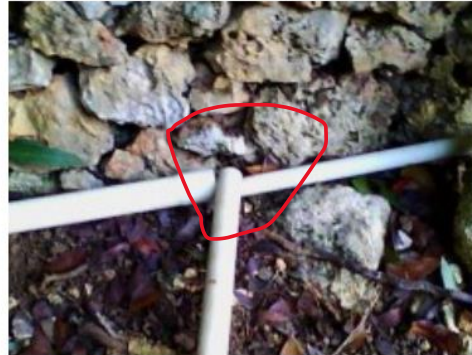
FLIR0863.jpg

Conduit connections in the yard heading to villa

Target Temperature	Reference Temperature	Temperature Difference	Criticality Rating
N/A	N/A	N/A	
Amperage A	Amperage B	Amperage C	Rated Amps/Volts
N/A	N/A	N/A	100A / 120/220V
Comments: Distribution conduit from Incoming power connections to villa – picture for reference only			
Recommendations: As above.

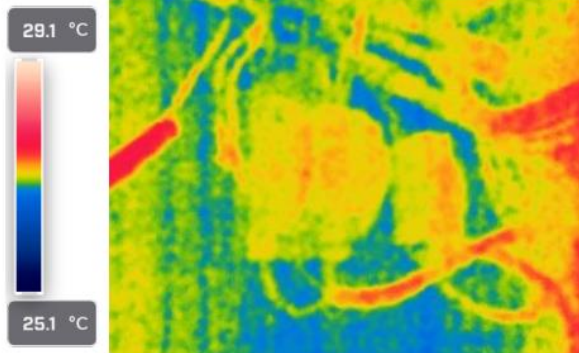
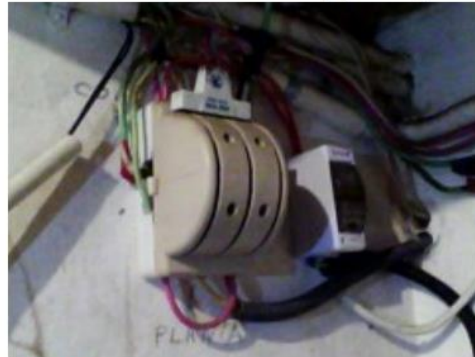
FLIR0843.jpg

100A main disconnect in cellar and tie in to backup power system

Recommendations – Short term: remove redundant cables, move switch if possible to make space to declutter cables at the top

Recommendations – long term: remove 100A disconnect switch and install a proper disconnect switch. Declutter all cables and remove unused cables and unused backup power system. See picture below.

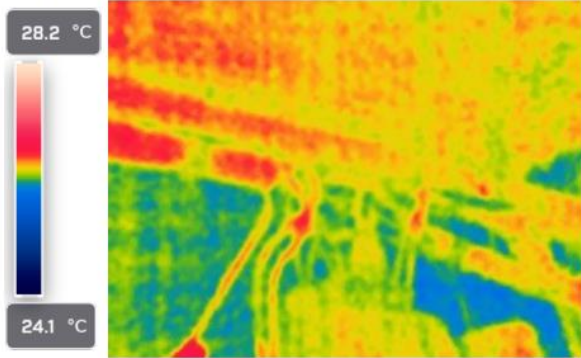
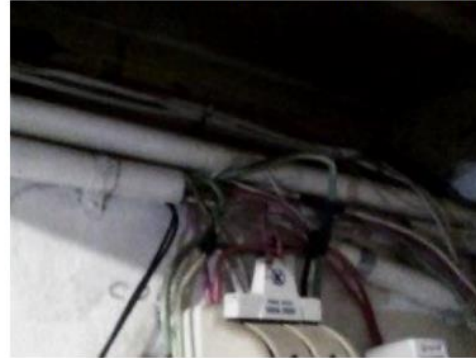
FLIR0845.jpg

100A main disconnect close up

Recommendations: As above, showing some cable heating due to cable crowding.

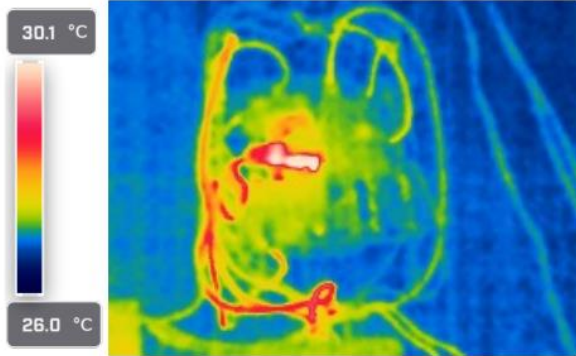
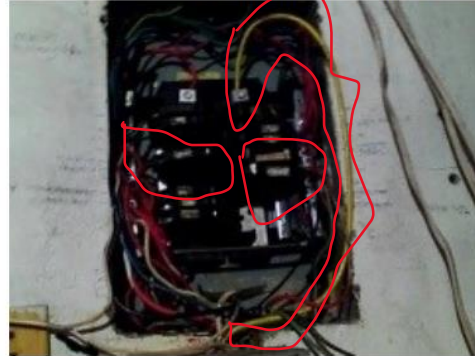
FLIR0849.jpg

Villa cellar and 2 main panels – upper breaker panel – we discovered that there are several deficiencies here. 1) double landed breakers (breakers feeding more than 1 circuit), 2) wire cut off breakers left hanging (this may account for some dead circuits inside and outside), 3) breakers not affixed properly in panel due to broken bus pieces. 4) no cover, 5) no standard north American or European wire color scheme used. 6) yellow power wire appears too small for amperage, 7) poorly / improperly connected neutrals and ground wires. 8) loose wire connections on breakers. 9) box generally messy and overcrowded. See page 21. Lower breaker panel finding similar to upper panel. See pages 22 and 23.

Cellar area upper breaker panel

Comments: Cellar area upper breaker panel – see recommendations, also hot connection on breaker.

Recommendations – short term: 1) install sufficient breakers for # of circuits, 2) remove cut off wire stubs, trace cut cables and reconnect to appropriate breakers, test circuits. 3) leave for time being, see long term recommendations. 4) install panel cover, 5) phase power wires with black electrical tape, neutrals with white and grounds with green for easy identification. 6) re run new wire 100A rated, check corresponding red for size. 7) check and tighten all connections, use proper bolted connections for grounds and neutral bar for neutrals. 8) remove and reinstall all breaker wires and test for tightness, 9) declutter box and separate wires where possible.

Recommendations – long term: 1) replace box and breakers with 100A 24cct panel cw cover, neutral and ground bus, reattach all wires using only 1 breaker per circuit, land all neutrals on neutral bus, land all ground wires on ground bus. Ensure all wires are appropriate size for amperage of breakers.

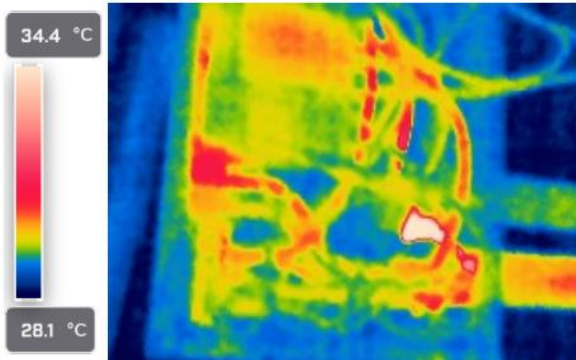
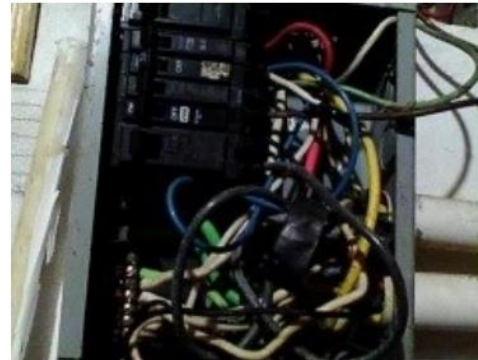
FLIR0851.jpg

Cellar area lower breaker panel

Recommendations: Same as for upper panel above.

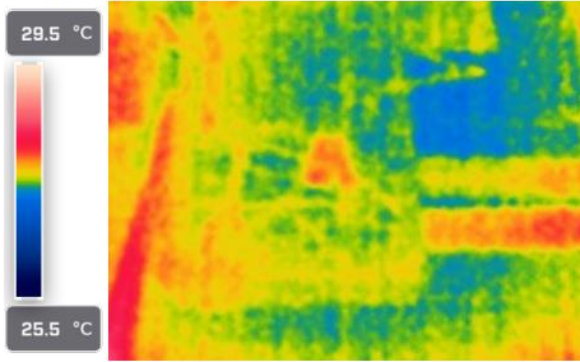
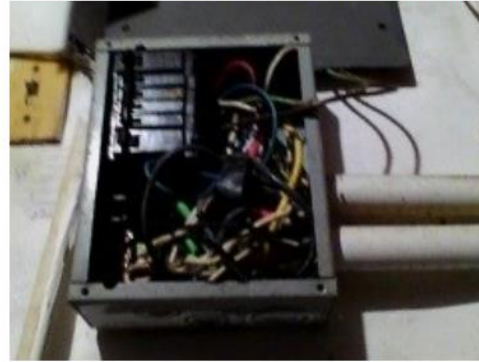
FLIR0847.jpg

Cellar area lower breaker panel

Target Temperature	Reference Temperature	Temperature Difference	Criticality Rating
30° C	30° C	35.6° C	*
Amperage A	Amperage B	Amperage C	Rated Amps/Volts
See table	See table	See table	60A / 120/220V
Comments: Cellar area lower breaker panel – see above			
Recommendations: see above recommendations

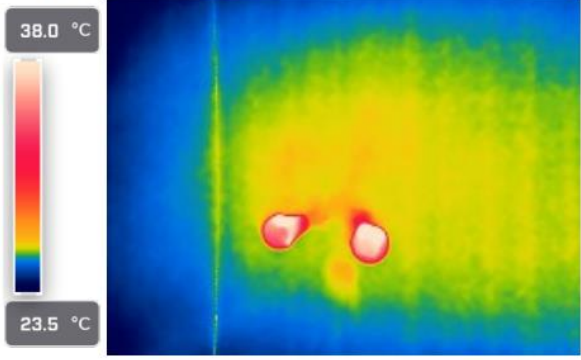
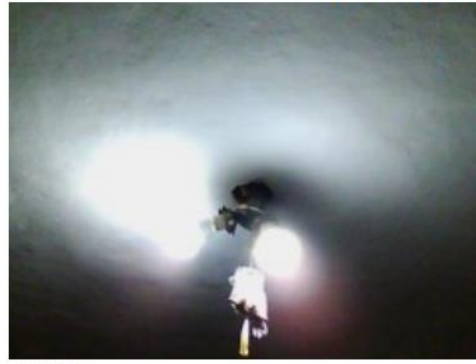
FLIR0855.jpg

Living room light

Recommendations: properly reattach to ceiling.

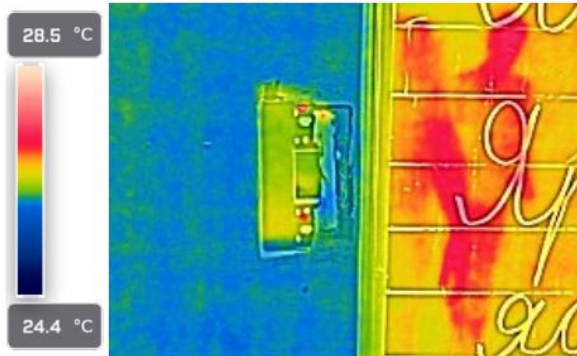
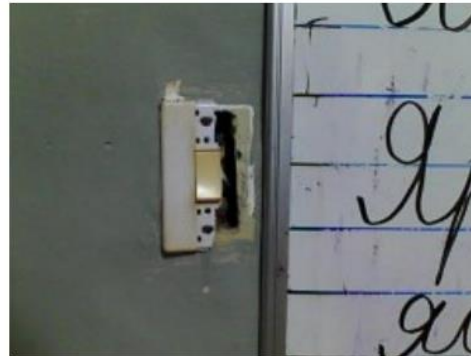
FLIR0887.jpg

Main floor office area

Target Temperature	Reference Temperature	Temperature Difference	Criticality Rating
30° C	30° C	35.6° C	*
Amperage A	Amperage B	Amperage C	Rated Amps/Volts
See table	See table	See table	15A / 120V
Comments: Office area – picture for reference only			
Recommendations: replace with new switch cover for safety.

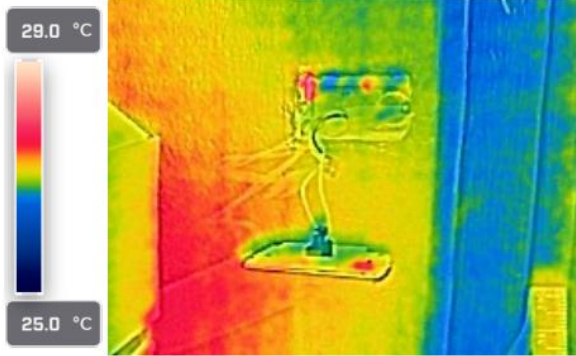
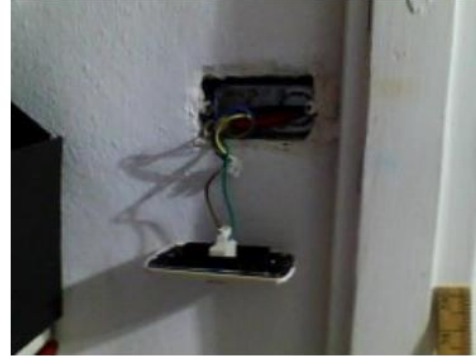
FLIR0889.jpg

main floor office area

Recommendations: reattach for safety.

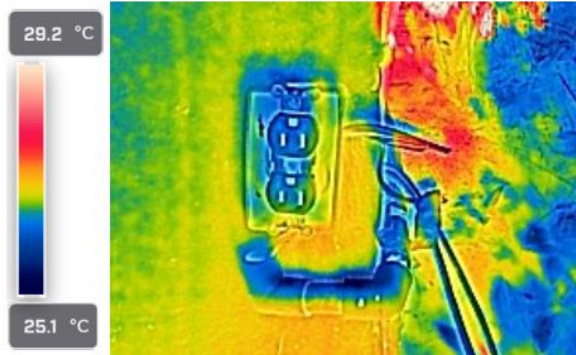
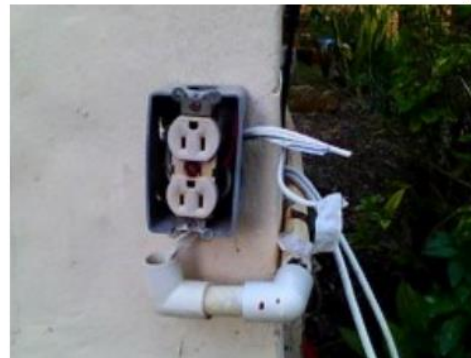
FLIR0865.jpg

outside face of building

Recommendations: replace conduit with proper conduit, replace plug and box with proper outdoor rated equipment.

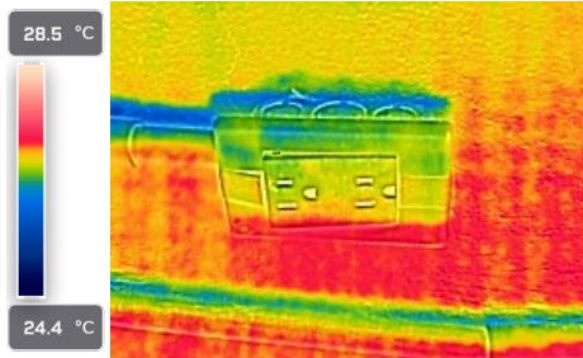
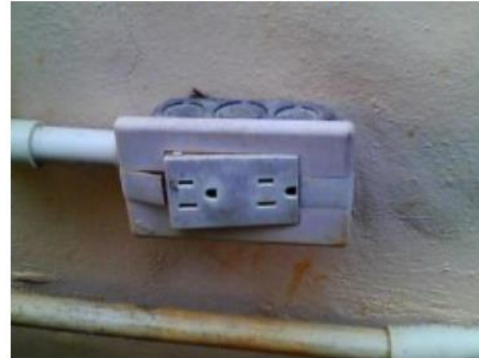
FLIR0867.jpg

outside face of building by front entrance

Target Temperature	Reference Temperature	Temperature Difference	Criticality Rating
30° C	30° C	35.6° C	*
Amperage A	Amperage B	Amperage C	Rated Amps/Volts
See table	See table	See table	15A / 120V
Comments: Outside wall front of building – picture for reference only			
Recommendations: Same as above.

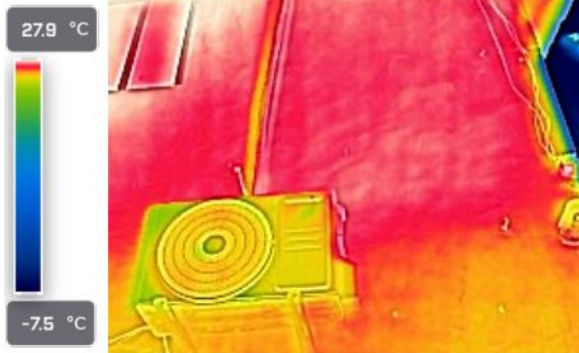
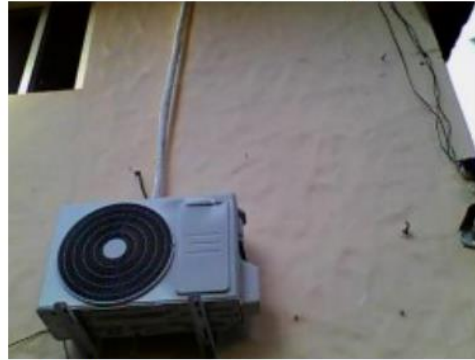
FLIR0875.jpg

outside face of building side of villa

Recommendations: None all 3 AC units function properly.

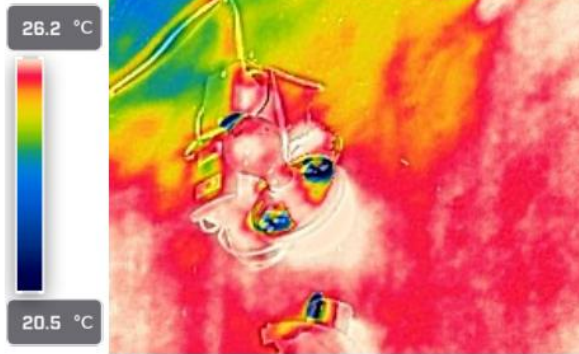
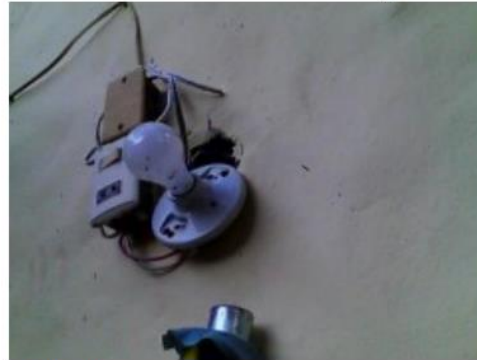
FLIR0877.jpg

outside face of building rear wall

Recommendations: Use conduit to encase wires, change switch and light fixture to outdoor rated, motion detection preferable.

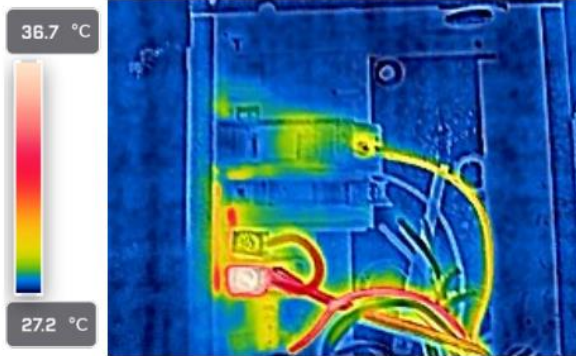
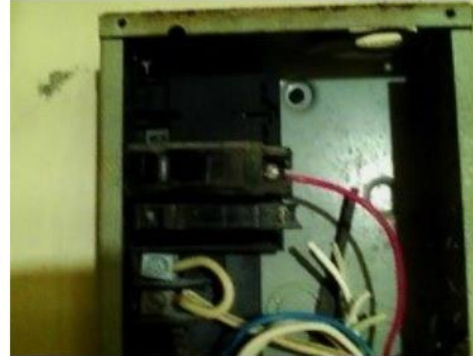
FLIR0879.jpg

Villa pool enclosure – we discovered that the pool pump breaker panel is open and has no cover, there is no switch for the pump the breaker must be actuated manually (dangerous). There is a hot spot on the neutral connection, the pump connection box is open, the feed cable to the pump motor is the wrong type, ampacity and has a hot spot on the poorly made connection. See pages 31 to 34.

breaker panel in pool pump enclosure

Recommendations: panel requires a cover, check and tighten connection on breaker and neutral, add a switch to the cct so the operator doesn't have to turn on and off using the breaker.

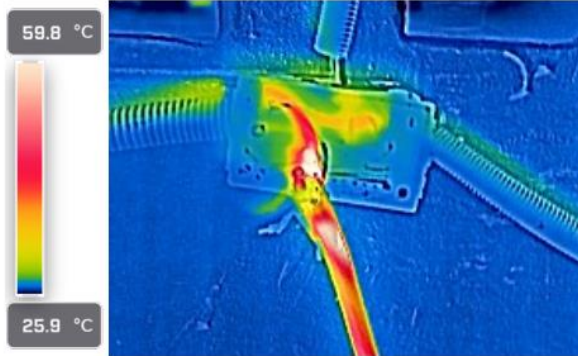
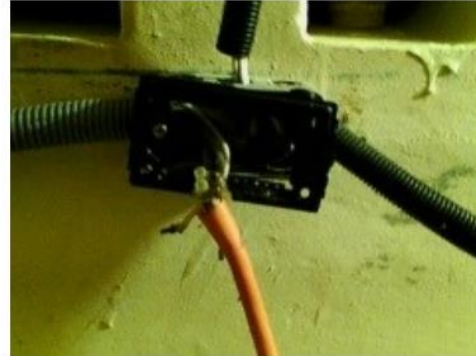
FLIR0881.jpg

pool pump motor cable junction box

Recommendations: Criticality rating of 3 means failure likely, replace immediately. Replace cable with properly sized and rated cable, make solid bolted connections. Cover junction box.

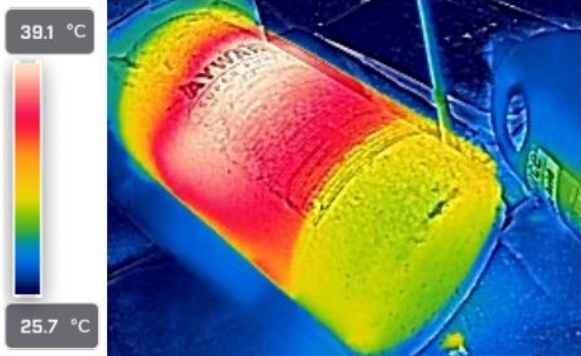
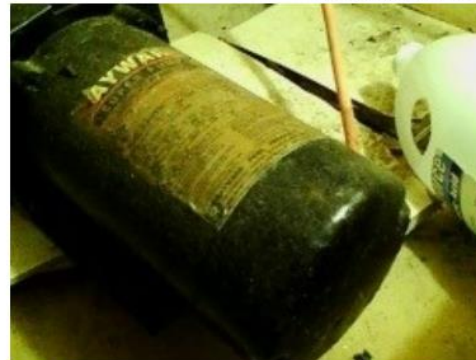
FLIR0883.jpg

pool pump motor

Recommendations: None, normal temperature rise for a motor.

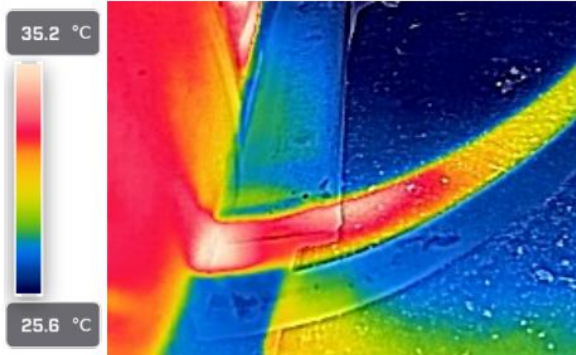
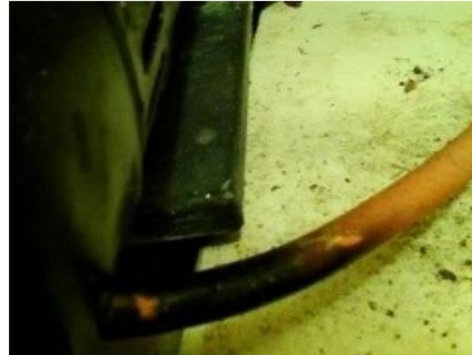
FLIR0885.jpg

Pool pump motor feed cable connection

Target Temperature	Reference Temperature	Temperature Difference	Criticality Rating
35.1° C	30° C	35.6° C	*
Amperage A	Amperage B	Amperage C	Rated Amps/Volts
See table	See table	See table	20A / 120V
Comments: Pool enclosure pool pump connection junction box – picture for reference only			
Recommendations: Replace cable, signs of overheating, see above.
