# JC Termografía RD

**Report for:**  
**Hotel Playa Laguna**  
**Escondido Bay Carretera Cabarete - Sosua, Puerto Plata Republica**  
**Dominicana**  
**Tel : (001) 809 571 3375 956**  
Inspected on: 11/06/2021

## Infra-red Electrical / Pool Inspection Report

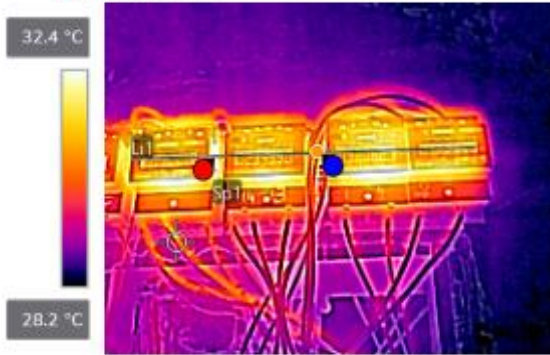
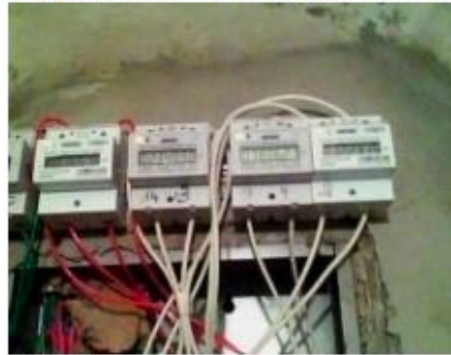
FLIR0187.jpg

Panel #1 single phase metering section right side

Recommendations: short term – none.

Recommendations: long term – none.
