Report for:
Mike's Mountain Saloon
Mountain Top near Moca
Tel : (+49) 173 537 6669
Inspected on: 11/27/2021

Infra-red Electrical Inspection Report

Location / Name: Mike's Mountain Saloon, Main Building

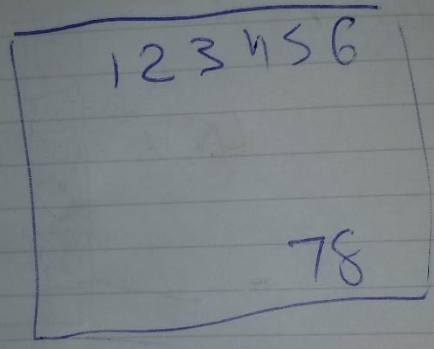
PANEL SALOON

- 1 V=114 A 0.3A Kitchen + Storage LT
- 2 V=114 A 0.4A Office + Saloon
- 3 V=114 A 0.5A Plus Office + outside
- 4 V=114 A 0.2A
- 5 V=114 A
- 6 V=114 A 0.1 Bar Lits
- 7 V=114 A 0.2 Kitchen
- 8 V=114 A 0.5A Saloon + outside Lts
